## ALERT ▶

### MEWP Crush Injury

This alert has been created based on details provided by Vinci Taylor Woodrow following an incident on 22<sup>nd</sup> July 2015 at Old Oak Common site.

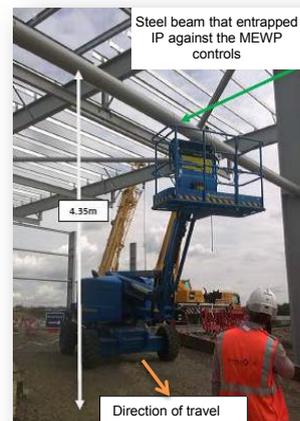
During the construction of the OMC building steel frame, a steel erector was involved in an incident whilst operating a MEWP travelling down a ramp. The MEWP was being operated with the basket at height (not at stowed position) at the time of incident.

The IP was crushed between a circular hollow section beam and the MEWP controls, sustaining a punctured lung, two broken ribs and a broken wrist as a result. The MEWP was fitted with a secondary guarding device, which was activated on impact and cut the power from the machine.

- Ensure any MEWP selected is capable of satisfying the site requirement – IPAF's (International Powered Access federation) 'MEWPs for Managers' course offers recognised training in this area.

- Ensure secondary guarding systems are fitted (e.g. Sky Siren, Sanctuary Zone).
- Ensure operators are competent, e.g. to IPAF (Powered Access Licence) Category 3b standards.

- Ensure competent operators are familiar with the controls of make/model of MEWP supplied.
- Ensure that nominated individuals are trained and familiar with emergency lowering requirements.

- Ensure that dynamic risk assessment has and will continue to be undertaken, notably by those persons operating the MEWP.
- Ensure the competent operator is wearing a full body harness and is appropriately secured by lanyard to designated anchor points only within the basket.

- Ensure that appropriate plant and pedestrian exclusions zones are set up around the operating envelope of the MEWP.
- Ensure that the MEWP is operated only in accordance with the manufacturer's instructions.

- Consider, for more complex structures/locations, that operators be trained to the higher IPAF PAL+ standards.
