## Service damage Somerset Highways

Incident notification

### Details of incident: IN011123

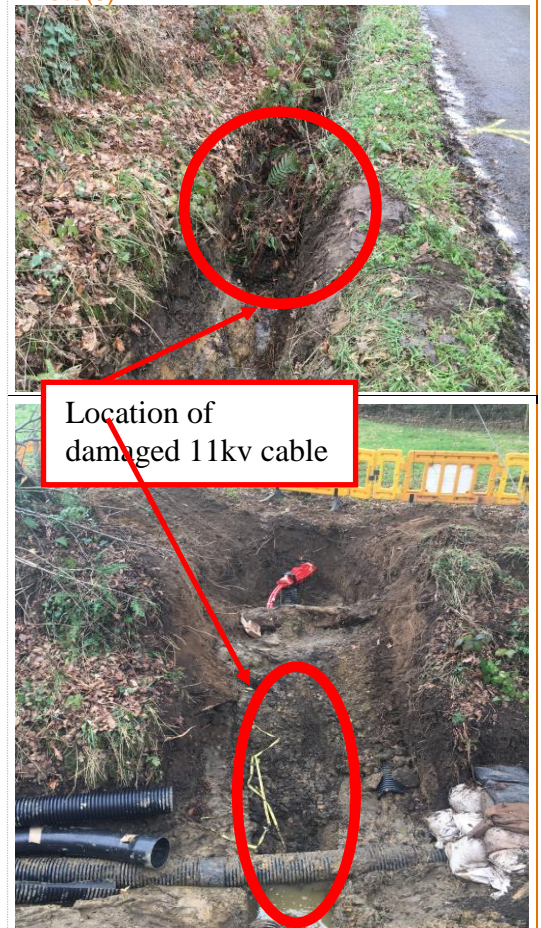
Whilst conducting ditch clearance works using a 6 tonne rubber duck excavator, an 11kv cable was damaged during the operation which crossed the ditch from the carriageway to a nearby pylon.

A ditching bucket was being used to carry out the works and sustained slight damage.

It was reported that smoke and sparking was observed but no major flash at the point of impact.

The HV service was installed in the 1970's and would have been originally excavated below the ditch base. Following years of ditch clearance works, the base level of the ditch may have been reduced over time which then left the cable exposed. The ditch at the time of the initial investigation was flowing with a good stream of water and this, over time, could have eroded the base of the ditch.

Statutory drawings were available on site but were only verbally briefed to the excavator driver conducting the ditching.

Cable Avoidance scanning was not conducted prior to the ditching works but there was a scanner being used on the drainage works conducted close by.

- Any additional works added to a schemes package post start date must be suitably and sufficiently planned
- Cable Avoidance scanning must be conducted prior to breaking ground operations
- Visual inspection of surrounding area, including reference points from statutory drawings to be mandated as part of the excavation process
- Approved Safe Systems of Work (SSoW) to be in place for all operations.
- SSoW must include the provision of statutory drawing & Cable Avoidance Equipment.
- Ditching activities: All OU's to review their current procedure regarding ditch clearance. As part of the operation,

statutory drawing must be presented to the site team along with the Mandatory use of Cable Avoidance Equipment.

- All OU's to discuss this alert with all current ditch clearance contractors.
