## Operations Lantern canopy falling from a Column onto vehicle

February 2018

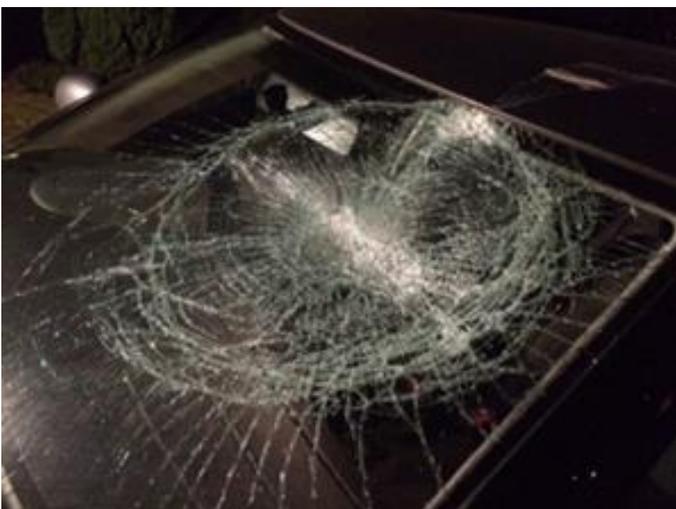
A Philips Iridium2 HID Large lantern canopy weighing 6kg parted from the rest of the lantern from a height of 12 metres and damaged a vehicle window screen. Fortunately no-one was injured.

The rest of the lantern was recovered allowing investigation. It was discovered that the canopy clip 'spring' was weak permitting excessive play. Further investigations are planned to identify if this is an isolated or wider problem, and, whether the spring was weakened as a result of falling to ground.

All sections of the network where this type of luminaire are installed should be scouted to identify units at risk of separation failure.

- Re-secure and ensure the clasp is secure.
- Secure the canopy with either heavy duty cable ties or tespa bands or similar.
