30th August
2015

Safety Memo

Area 10 MEWP Incident

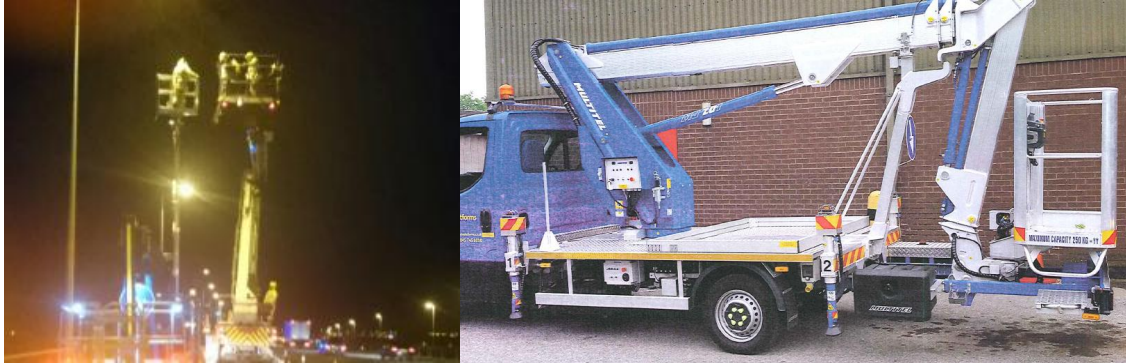
A recent incident occurred in Area 10 involving a Mobile Elevated Work Platform (MEWP) where an operative was stuck for a few hours in the elevated basket.

The operator was coming down from the lighting column when the bucket tilted backwards and everything cut out. The emergency procedure was followed as per the manufacturer's guidelines by using the battery backup; however this failed to operate and the emergency services were called to bring the operator down safely.

This machine (Pictured above) is a Multi-Tel MJ201. The MEWP has a safety feature where if the cage tilts back beyond 10 degrees, the machine cuts out.

- All operators must be certified with either CPCS or IPAF applicable to the item of plant being used
- All operators must be given familiarisation training on the particular equipment on delivery. The familiarisation must include the machine specific emergency lowering information
- Someone on the ground should know what to do in an emergency and how to operate the machine's ground controls
- The Emergency Lowering Operational Mechanism must be operated during the daily check of the equipment
- Daily/Weekly MEWP Checklist (Form - HSEN-SF0011) must be completed prior to use. The form must be within the vehicle for inspection when requested. The form is to be handed in to the office and filed weekly
- All operators must be trained in the "Use of Harnesses"
