Material failure to Dipper Arm of an 8T Hitachi Excavator

Incident Description

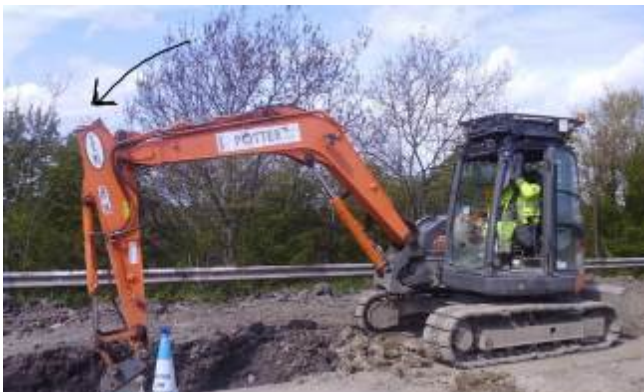
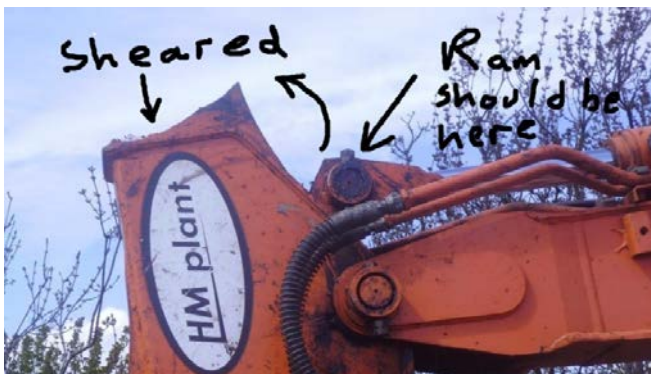
The excavator, fitted with a ditching bucket, was excavating a shallow trench when the lugs of the front dipper arm sheared (at top arm cylinder bracket – refer to photos below).

Initial (visual) investigation has suggested steelwork material failure (fatigue) to the lug/s **(Not the welds)**.

- The Excavator was stood down immediately, and has been removed from site. No-one was injured.
- As a further precaution, another 3 Excavators of this type on site have also been stood down and further inspected. No visible deterioration was found.
- Hitachi Construction Machinery UK (manufacturer) was contacted, and in response:
- They provided a “Product Alert” issued by Hitachi in April 2016 relating to their having received several reports of fractures in arm cylinder brackets, which have gone unnoticed and eventually resulting in total separation due to fatigue.
- Representatives from Hitachi visited site to view the damage on Mon 09 May 2016, and their investigation to determine causation is on-going.
