SAFETY ALERT

Overtuned 6t Dumper

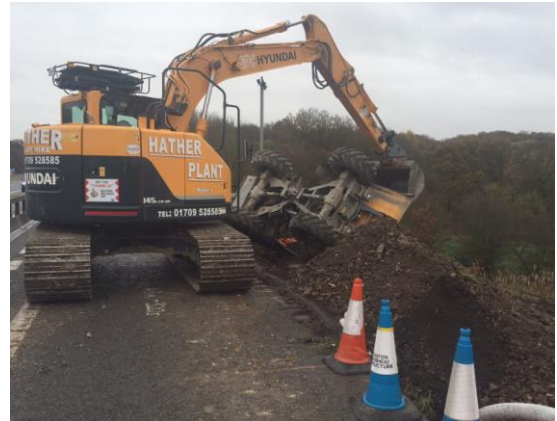
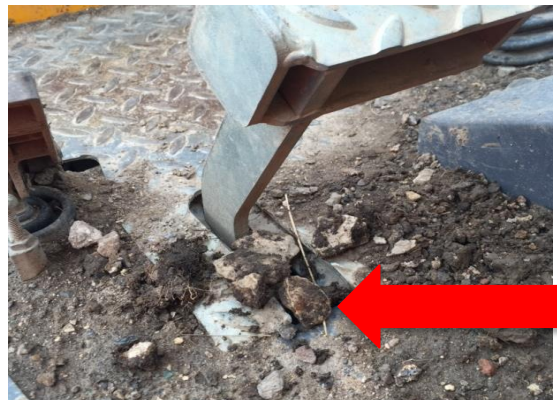
- The dumper encroached too close to the road edge whilst transporting material
- The operator stated that on approach to the tipping point the dumper brake failed to engage, this resulted in the dumper entering the reduced level area, causing it to overturn
- Prior to the accident, the dumper was being loaded with recycled concrete materials; it is believed that this material may have caused the failure of the braking mechanism, by becoming lodged underneath.

Red Arrow – pointing to small stones in/around the brake pedal.

- Re-iterate the importance of continuing checks of safety critical components during operation
- Re-iterate to all plant operators the importance of ensuring debris does not build up around any operating pedals
- A reminder to all that Highways England 'Raising the Bar' No.1 stipulates a requirement for dynamic brake efficiency testing to be conducted every 6 months - see below link.
- Reinforce importance of wearing seat belts - see below video link from another Costain contract.
