# Falling TM Signage

## *Safety Alert*

June 2017

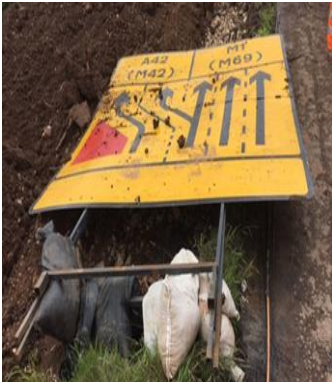
Two operatives were struck on the back of their hard hats by a falling TM sign that had blown over in strong winds. The sign was approximately 2400mm x 2400mm in size.

The operatives were stood in front of the sign at the time of the incident observing the loading of nearby plant.

- The RAMS did not identify the requirements for sufficient ballast
- Supplier/manufacturer of TM signage did not provide recommendations of minimum ballast requirement as per guidance in BS 8442:2015
- Weather conditions on the day of the incident were not considered as part of the start of shift briefing
- TM signage was not considered within the Temporary Works register for the project therefore no historic assessment was carried out to deem whether existing measures were sufficient.

- Consider daily weather reports for inclusion in Start of Shift briefings.
- Risk of temporary signs falling in high winds to be briefed during Start of Shift briefings.
- Inspect signage to ensure sufficient ballast.
- Review Temporary Works requirements of Temporary Traffic Management signage.
- Review site TM signs and establish if, where practicable, long term signs can be erected on passive poles or whether non-essential signs can be removed.
