Finger Entrapment in Barrier Driving Rig

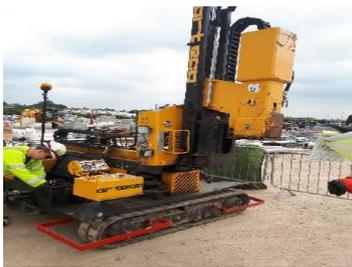
Orteco Post Kocker

During the setting up process of an Orteco post knocker, an operative had the end of his middle finger cut off. The contractors hadn't noticed that the lower jack ram was extended upwards into the percussion head. This put pressure onto the lower mast extension release pin, trapping it. The pin was spring-loaded and the operatives thought it was jammed. One operative pulled out the pin with a pair of mole grips, whilst another operative was holding the slide extension. The pin released, the slide extension moved forward. This disengaged the lower jack arm allowing the percussion head to drop, trapping his finger between the percussion head and the lower mast severing the tip instantly.

Mast release pin in unlocked position

Location of Mast release pin and safety lock pin (red)

Lower Jack Ram extended onto Head

Finger trapped between percussion head and extension at this location.

- Operatives didn't stop work when something changed.
- Too many operatives involved.
- Nobody had taken charge of the task.
- No communication between those involved.
- They were not undertaking the task as per training.
- A vital safety component was missing, the safety lock (red) pin which prevents the head from coming down the mast.

- Ensure cooperation and communication between operatives.
- Check safety components are in place before using equipment.
- Make sure pre-start checks are done correctly.
- Ensure safe systems of work are in place and followed.
- Re-affirm the Golden Rules: Stop work if anything changes or safe systems of work have not been followed. This may have led to the missing locking pin and extended ram being noticed here.

- Suspension of Orteco operations on MSM.
- Review of safe systems of work.
- Orteco rigs quarantined awaiting mechanical inspection by qualified body.
- All operatives to be reviewed and if deemed appropriate sent for re-training
- Investigation ongoing to identify further learning points and corrective actions.
