## Bridge Deck Coring Incident

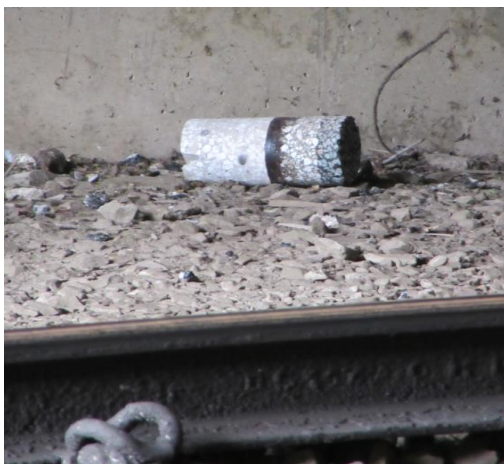
On 19<sup>th</sup> July, an operative was undertaking core sampling on a carriageway over a railway. During the activity the core drill penetrated through the bridge deck causing the core sample to fall onto the side of an operational railway line below.

Fortunately, the core did not hit a train or injure anyone in this instance but the potential consequences could have been severe.

- Review core drilling risk assessments and method statements to ensure they are suitable and sufficient. Ensure the appropriate controls are discussed with teams before work begins.
- Ensure appropriate safeguards/procedures in place to protect any structures at risk of damage prior to work commencing where required.
- Designer's risk assessment should address the risk of damage to infrastructure.
