Reportable Injury – M54 Electrical Burns

An incident occurred on the 22nd August where an electrician, working on the M54 lighting upgrade, sustained electrical burns to his hands whilst installing components into an electrical distribution board (feeder pillar).

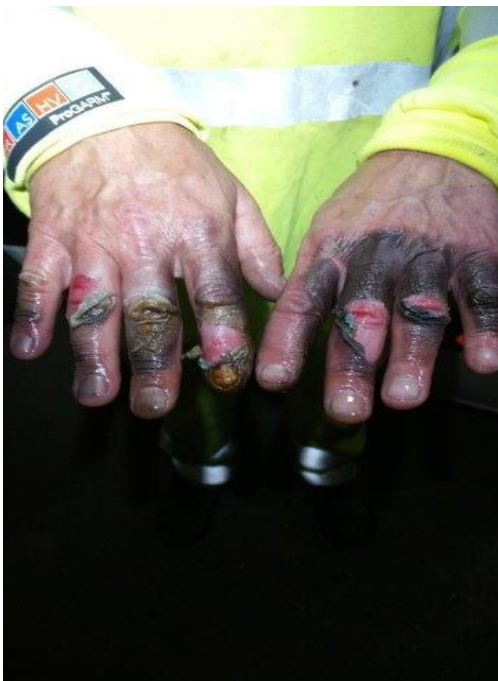
- The injured person failed to isolate the electrical supply and make the system dead.
- The injured person assumed the system was isolated from the previous night.
- The fuse carrier came into contact with a live component which caused a flash over whilst working on the feeder pillar.
- The protection cover on the panel has a warning label stating "isolate supply before removing this cover".
- None of the 3 isolation points for the feeder pillar, mains switch, rotary isolator and supply fuse were used to isolate the electrical supply.
- The site specific risks and controls and the permit to work instructions were not followed.

- Never assume electrical systems are dead prior to working on them. Anyone working on electrical systems must ensure they have been isolated and are safe to work on.
- Operatives must follow their company's safe working procedures for working on electrical systems.
- Operatives must test the electrical system to make sure it is dead.
- Lockout devices must be in place and visible before working on electrical systems.
- All live work must be controlled by a permit to work process.
- Brief electricians and operatives on this safety alert.
