An accident occurred on the 11th August 2017 at the M5 Oldbury Viaduct scheme, where an employee fractured their ankle when exiting the welfare unit.

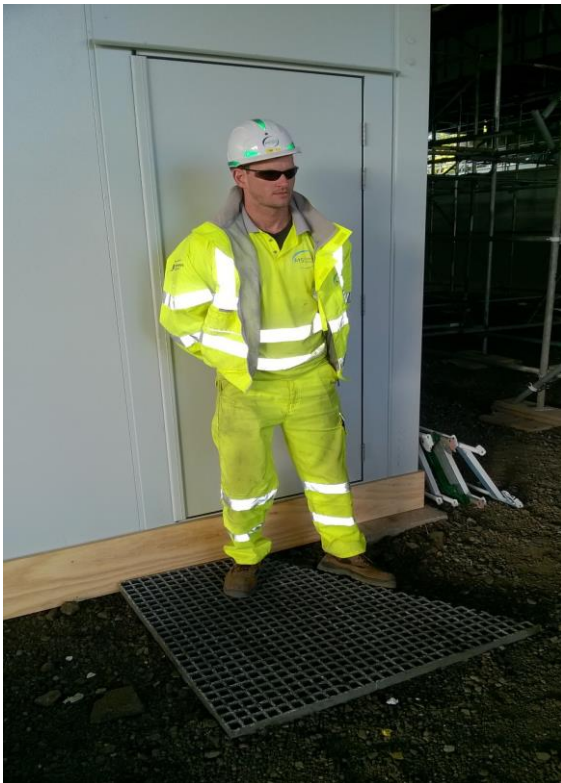
- The welfare unit was bought into use before being ready.
- The access steps had not been constructed on the entry and exit doorway of the welfare unit.
- An uneven quadrilateral shaped grill was placed outside of the unit with one edge aligned with the centre of the doorway.
- The part-complete welfare units were not locked.
- The risk assessment does not identify the risk and controls to be implemented for commissioning the welfare units after installation.
- The activity plan didn't identify person(s) responsible for the unit installation and commissioning

- Risk Assessment to cover the installation and commissioning of welfare facilities, with specific reference made to tasks being assigned to designated people.
- Consider locking and displaying signage on welfare units which are not ready for use.
- Site inspections to pick up the condition and access - egress of welfare facilities.
- Briefings to include hazard spotting and 'don't walk by rules' to encourage the reporting of defects with welfare facilities and across the site.
