High Potential Incident - Falling Concrete Block M5 Oldbury Viaduct

SafetyAlert

November 2017

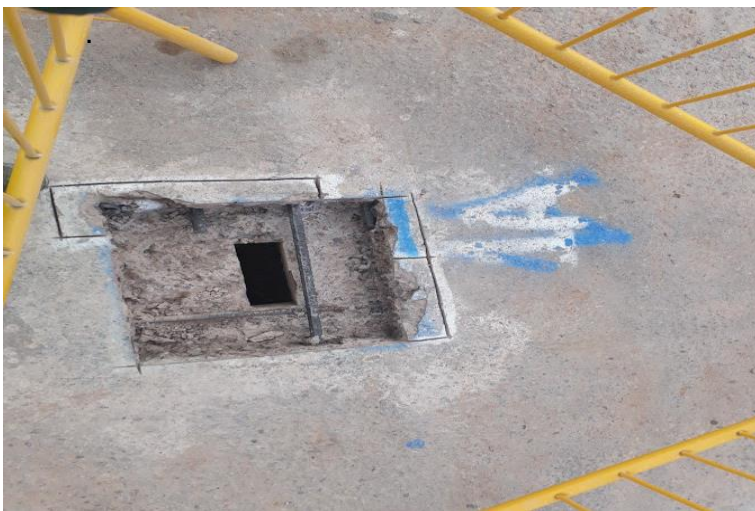
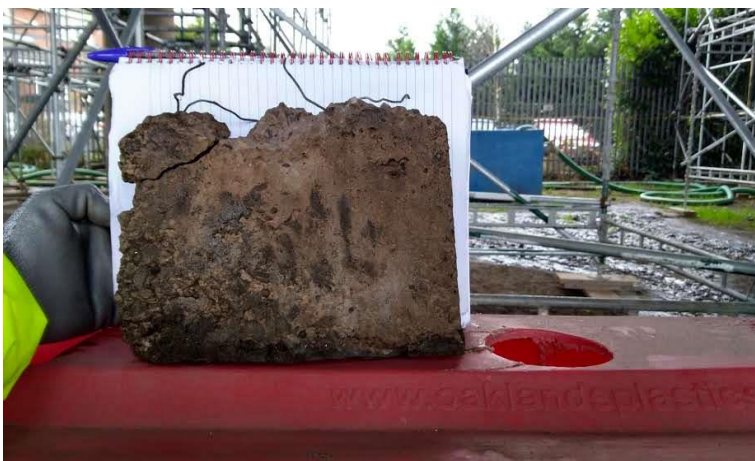
Whilst trimming a concrete repair with a mechanical hand breaker, a piece of the structure (approx. 200 x 300 mm) dislodged and dropped through the viaduct structure. It struck the arm of the unoccupied forklift situated below.

- No one was working in the immediate vicinity at the time. The forklift sustained minor damage.
- Works were immediately suspended and discussions have been undertaken as to which method of work is most appropriate to control this type of hazard.
- A full investigation is underway.

- Identify locations and work tasks which represent a risk of injury or damage from falling debris.
- Ensure the method of work takes into account the potential for falling debris.
- Ensure the identified tasks and locations have suitable arrangements as part of the system of work to establish exclusion zones.
- Ensure that the risk assessment identifies the controls for establishing an exclusion zone and how they will be implemented and monitored.
- Consider how exclusion zones are to be clearly marked and what barriers are required to prevent access into zoned areas.
- Consider all people affected by the operation and ensure the system of work provides sufficient resource, information, training and supervision to control this type of hazard.
