## White Lining Machine Incident

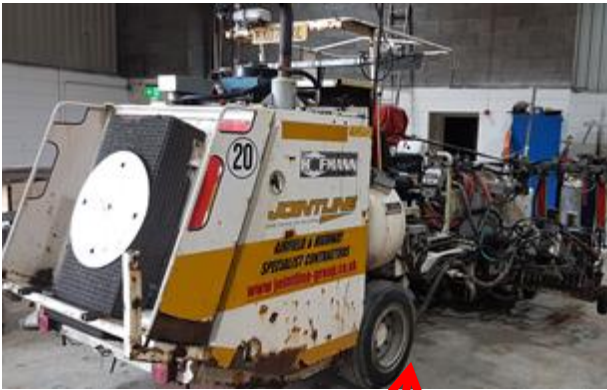
Whilst attempting to climb back onto the moving machine, the IP slipped and fell to the ground. The machine then rolled over both legs resulting in severe grazing and bruising.

Legs trapped under wheel

The investigation determined that the IP tried to climb onto the vehicle at a non-recognised access point whilst it was still in motion.

The Risk Assessments and Method Statements (RAMS) did not consider the presence of a second person on the machine for training purposes, nor did it state the requirement for the vehicle to be stationary prior to operatives alighting.

- Review RAMS associated with working on plant or machinery to ensure they are suitable and sufficient.
- Ensure the controls in these assessments are discussed and understood by each individual before work begins
- Personnel must not access or egress moving machinery
- Ensure all operators are suitably trained and competent to use the machinery
