Incident Description:

On the 9th February 2018 at 2010, during refuelling operations, the rear drum of a roller came into contact with a surfacing operative's left foot resulting in a broken big toe.

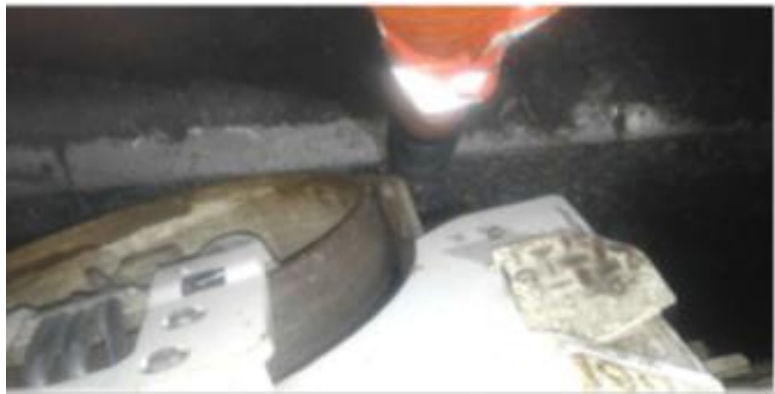
1. Improper decision making or lack of judgement - Roller driver moved before he was certain the IP was clear of the machine
2. Lighting Issues - Lighting to the area was good but once other plant had left the parking area, the section where the incident occurred was dark.
3. The safe system of work that manages the risk of the people plant interface was not adopted. The IP was stood in close proximity to plant which was prohibited under the SSOW.
4. Lack of spatial awareness - The IP believed he was in a position of safety due to the fact he was stood on a raised verge. His foot was hanging over the verge / half battered kerbstone allowing contact with rear drum of the roller.

- Ensure that plant operators and site personnel are aware of ALL safe systems of work for their particular tasks
- When operating plant and equipment guards, ensure the safe system of work that has been identified and is implemented fully at the work site
- Ensure that the agreed controls are documented in the risk assessment for the activity and that these controls are implemented every time the activity is undertaken
- Ensure adequate supervision is present at site
- Ensure correct training has been given to the personnel who carry out the activity
- Ensure that safe system of work is included in pre - start site safety briefings and safety stand downs
