## Overhead Service Strike

During a night shift on Thursday 28<sup>th</sup> March 2018 on the M6 J16-19 Smart Motorways Project; a grab mounted lorry was removing verge spoil.

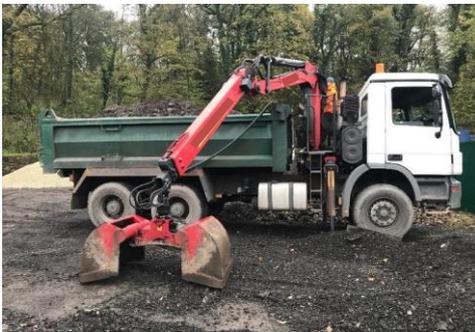
It was between J17-18 (Northbound) at approx. marker post 272/20 where an 11kV overhead line was struck by the extended arm of a grab mounted lorry (example below).

Image: Gmtree/Google, used for reference purposes and was not the actual vehicle involved.

One of three overhead lines was severed and another partially damaged. The tyre of the grab mounted lorry was destroyed due to the electrical contact.

- Site secured and made safe
- Distribution Network Operator (DNO) Scottish Power contacted
- Emergency services informed immediately
- Carriageway closed by emergency services to enable the removal of the 2nd damaged overhead line
- Investigation and sectional stand down for a briefing during the following day
- All work prohibited working beneath overhead services

- Ensure the location of all overhead structures and services are identified, shared with and understood by the workforce
- Ensure protection controls such as goal posts are effectively in place and maintained
- Ensure vehicle marshalls & plant operators are competent; and that adequate supervision is provided
