Overtaken excavator

A 20tonne tracked excavator was being offloaded from a delivery vehicle at the M6 J2-J4 Smart Motorway Programme project.

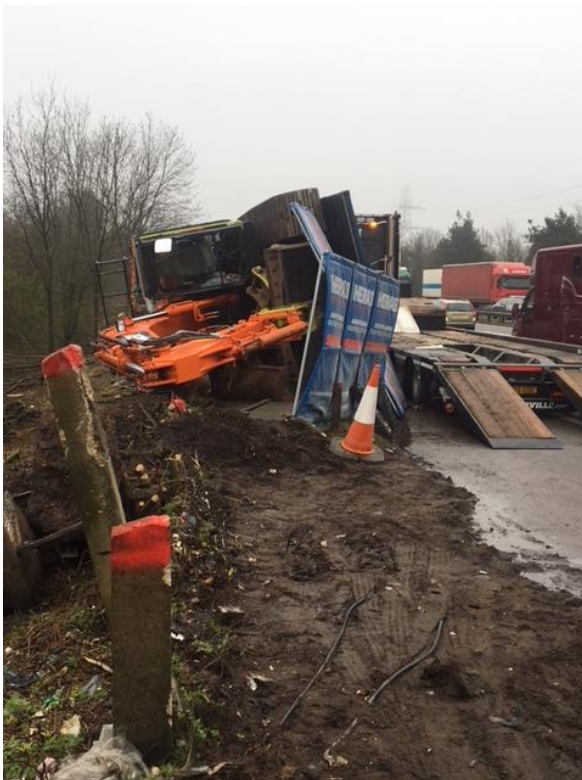
As it was being unloaded a bucket which had been stored in-between the tracks for transportation became stuck. The operator attempted to release the bucket resulting in the excavator falling from the side of the trailer, coming to rest on the verge.

Shown in the picture below:-

There were no workers or pedestrians within the area and the operator was able to exit the excavator to a place of safety unaided.

- Ensure ancillary equipment such as excavator buckets are not carried in-between the excavator tracks and a clear storage/transportation area is defined.
- Ensure plant delivery drivers are familiar with and work to safe working practices
- Ensure plant delivery drivers loading/off-loading plant from low loaders have the appropriate training and competence for the activity.
- Ensure there is a banksman or similar supervising and controlling delivery operations.
