# Safety Alert

## MEWP Boom Failure

2018/UK/SA/002  
12 December 2018

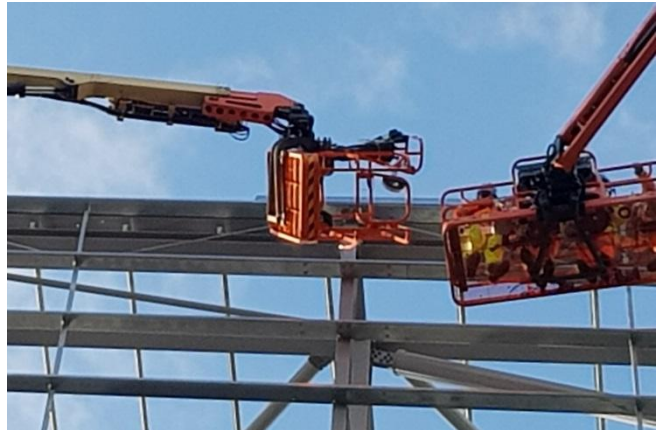
A JLG1850 boom type MEWP was working at high level (approximately 40m above the ground) when it failed to respond to the operating controls and then tipped to one side. The two operatives in the basket fell (within the basket) but were unharmed. A high level rescue was performed by an adjacent MEWP and the operatives were recovered to the ground safely and without further incident.

A thorough investigation is still on-going, with the components suspected of contributing to the incident being sent away for forensic examination. Whilst it is still too early to confirm the cause of the failure, one of the contributing factors is now known to be a check valve that was found to be stuck in the open position.

- Making sure that all operatives using boom type MEWPs are correctly wearing their harnesses and clipped on. The fact that both individuals were correctly clipped on in this incident may have saved their lives.

- Check that all MEWPs on arrival have been correctly serviced in line with manufacturers requirements and this specifically includes changing hydraulic fluids at correctly specified timescales

- Check that all MEWPs clearly show when the next service is due both in terms of a date and hours worked (whichever is the sooner). It is worth noting that some hire companies will only service their units when they are off-hired and returned to the depots. However, if you are using a unit for long period of time or for multiple shifts, then the time before the next service can be dramatically reduced

- Remind operatives that if they notice any abnormal movement when operating MEWPS, they should immediately return to ground level and report it.
