**Incident description:**

As part of enabling works on the M23 a pack of communication ducting was being offloaded by a lorry mounted crane (LMC) on the 2<sup>nd</sup> February 2017.

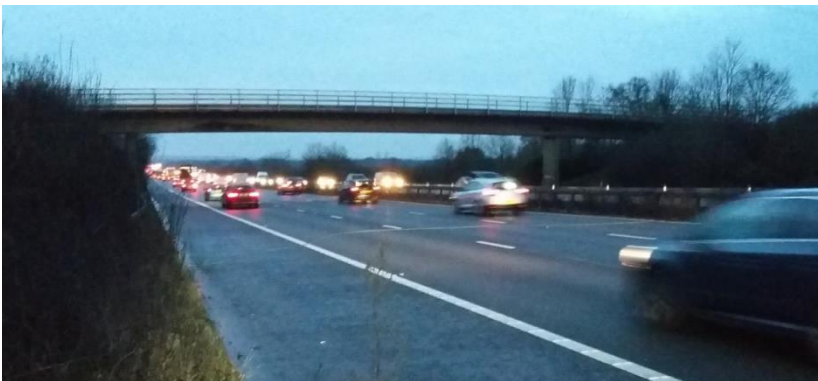
As the LMC was being raised it came into close proximity to an 11Kv overhead cable causing the cable to arc resulting in a flash. The cable became separated and fell onto the embankment and the south bound carriageway. The LMC was not struck, however the lifting chains took the electrical arc and sustained minor damage.

- Blue cones had not been placed across the closed carriageway to denote the position of the Over Head Line (OHL) as prescribed within the Health, Safety and Environmental Management Plan.
- The location had been misinterpreted from the service plan and as a result the pre-works briefing gave the wrong marker post location for the OHL.
- The incident wasn't escalated higher than bronze resulting in the cable being left in the live lanes; this was due to a lack of understanding of electrical hazards and who was responsible ie Service Provider or RCC.
- Incident commander not established and escalation to duty operations manager wasn't in a timely manner.
- Scene exclusion zone not communicated to traffic officers in a timely manner.

- Check the accuracy of all service drawings and ensure legends are clear.
- Ensure all sites with significant hazards are checked during daylight hours prior to work starting by an appointed responsible person.
- All OHL's to be identified with blue cones and/or goal posts. Work must not commence until these are in place.
- The information from within the Construction Phase Plan are to be used to deliver pre-works briefings rather than relying on information within the service drawings.
- Ensure there is a robust system in place for incident management within the incident management plan.
- Ensure there is suitable and sufficient Supervision for the risks on site and the complexity of the works.
