## High Potential Event & Dangerous Occurrence

### M3 Smart Motorway - Overhead cables struck by mobile tower light

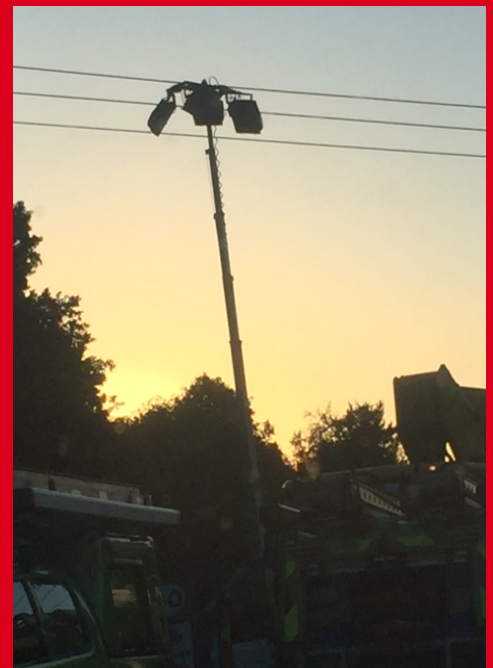
- Whilst undertaking night time strimming of the carriageway verge, a lighting head of a mobile tower light came into contact with 33kV overhead power lines.
- Emergency services attended the scene where the operatives involved were assessed. Two operatives were taken to hospital for further tests and assessment.

- All projects and operations must ensure that measures to protect overhead cables are in place in line with Raising the Bar 7 – Overhead Structure and Services Protection and HSE Guidance - GS6.
- The Planning of work activities is a key component to managing risk. Specific working areas must be considered when conducting risk assessments and developing work package plans.
- Hazards must be clearly identified during the start of shift briefing and it is good practice to take 10 minutes to inspect any new work area for additional hazards prior commencing work activity
- Additional consideration must be given when working during hours of darkness when overhead cables may not be visible.

- Exclusion zone setup around the incident area (the overhead cables were still live).
- Electrical distribution company attended to make the cables safe and undertake a condition survey.
