Title - Lost Time Injury - 17th January 2017 A21 Tonbridge to Pembury Dualling

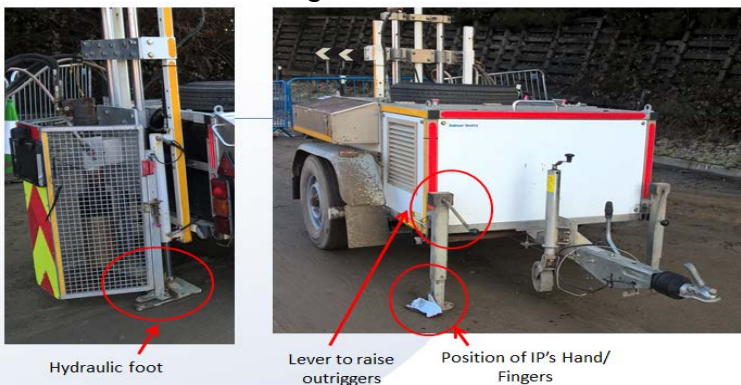
- IP Injured finger whilst setting up a coring rig. (Crush Injury)
- The team arrived at the location & positioned the rig for the core. They put the handbrake of the rig on and put the jockey wheel down.
- They then turned on the engine which meant the hydraulic foot was pressurised – this caused the rig to tip forward slightly and rest on the tow ball.
- The rig was on a slight slope so each operative adjusted an outrigger leg and started to raise it.
- The rig slipped from the resting position on the tow ball crushing IP's middle finger

- If the truck had been moved away from the rig it would have rested back on the Jockey wheel rather than the tow ball.
- When raising the outrigger legs you should not hold the base plate.
- The methodology & the rig are being reviewed, Team has been re-briefed & incident investigated.

- Revised the WPP & RA to include specific detail from this incident and rebrief to all Lab Staff
- Reviewed the coring rig itself to identify if other rigs are available or a better methodology should be used.
- Created a H&S alert/presentation on the incident and share with BB, HE & other contractors
- Shared lessons learnt with the whole project in morning prayers
- Arranged for specific training on the rig to be given to all lab technicians
- Carried out a review of Permit process to ensure all checks are done and relevant persons are appointed.
