Safety Alert

STRUCK BY OBJECT DURING REMOTE CUTTING OPERATIONS.

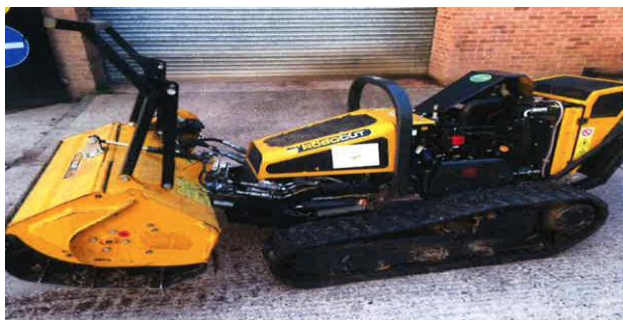
McCannel Robocut Mulcher

The causation was that during operations and as the mulcher was moving forward, the machine ran over a raised tree stump which caused the flail hood to lift allowing a lone piece of debris to shoot out and hit the operator from distance. The operations were carried out at night, and under a full road closure due to proximity and volume of live traffic. Work had been successfully carried out previously.

- Obstructions within the work area which had not been identified prior to starting work.
- Potentially unsatisfactory exclusion zones: manufacturer's recommendation states 5 m exclusion zone to the side of the equipment. This is currently under review with the manufacturer.
- Insufficient lighting to the work area is considered to be a contributory factor.

- Work suspended and an exclusion zone set up around the incident area.
- Robocut Mulcher suspended from use on the contract until additional controls and investigation completed.
- Safe Systems of Work (SSoW) reviewed ensuring exclusion zones are clearly identified and controlled effectively.
- Manufacturer (McConnel) contacted regarding lessons learnt and potential improvements to equipment and operator guidelines (ongoing).

- Safe Systems of Work to be fully reviewed.
- Provide suitable lighting levels for night ops.
- Re brief all robotcut operators on the safe operating procedures.
- Review safety distances – under review with manufacturer.
- SSoW – PPE – extra precautions relating to strimming leg guards reflected in Risk Assessment and Method Statement (RAMS).
