Form Ref: HSI-10	Independent Health & Safety Inspection – Blue Star Item	Version: 2.0 Jun 2015
----------------------------	--	---------------------------------

Project	Principal Contractor (PC)	Date of Inspection
M1 Junction 19	Skanska	24/06/15
Site Contact	Email Address	Telephone Number
Julie Clay	Julie.clay@skanska.co.uk	07814047212

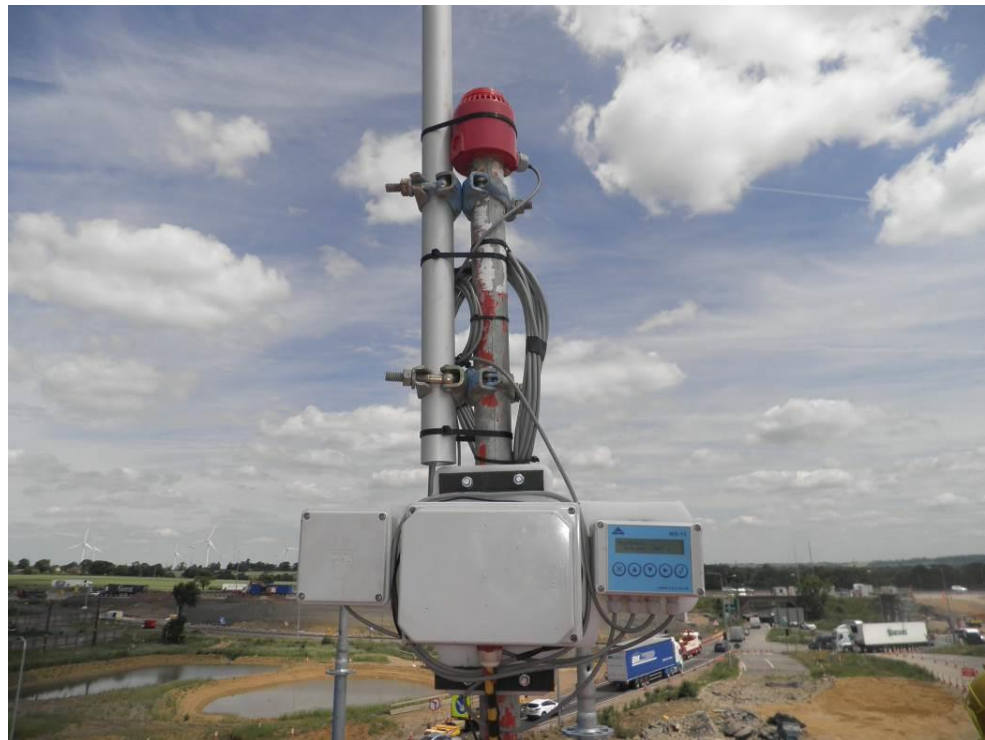
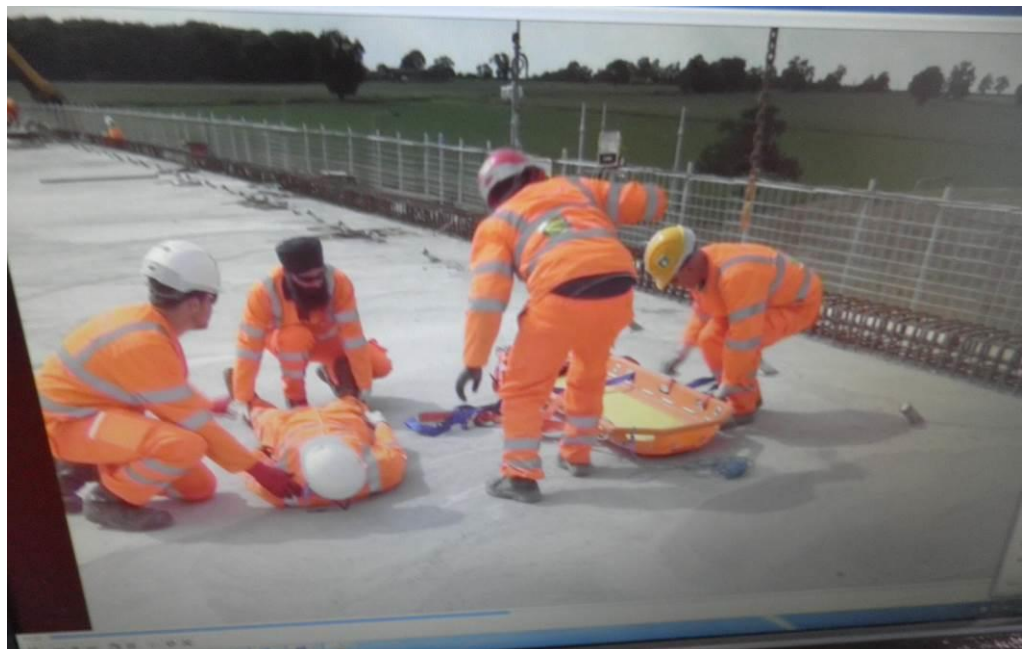
Description of Blue Star Item	Excellent emergency procedures in place for work on the bridge deck. Only those who need access are allowed on the deck and they receive a separate briefing. They then have to sign in and out every time they access the deck so that in the event of an emergency it is known who is on the deck. A wind monitor is located on the deck and no work is allowed if the wind speed exceeds 30 MPH. Alarm call points are located on the deck in the event of an incident and air horns also used to raise the alarm in the event of an incident. Rescue procedures in place and briefed prior to accessing the deck. A man riding basket and stretcher used to rescue casualties from the deck. Rescue training exercises regularly carried out with one taking place the day before the inspection.
Benefits of Blue Star Item	A well monitored access system to the bridge deck ensures that in the event of an emergency a roll call can be carried out quickly. Regular emergency rescue practices are carried out particularly where there has been a change in personnel working on the bridge decks to ensure that everyone is familiar with the procedures. The wind speed monitor quickly alerts everyone working on the bridge deck and gives them sufficient time to ensure that all materials are secured and that everyone can leave the deck safely.

Details and Cost of any Specific Product	Rescue stretcher and 4 point lifting bridle cost £450 FlexiMet Wind 1 wind speed and direction monitoring system cost £1069
