The incident occurred on 19th January at 12:45pm. At the time of the incident the IP was undertaking work on the M6 J13-15 Scheme, the location of the incident was a NRTS Chamber at MP 238/4B.

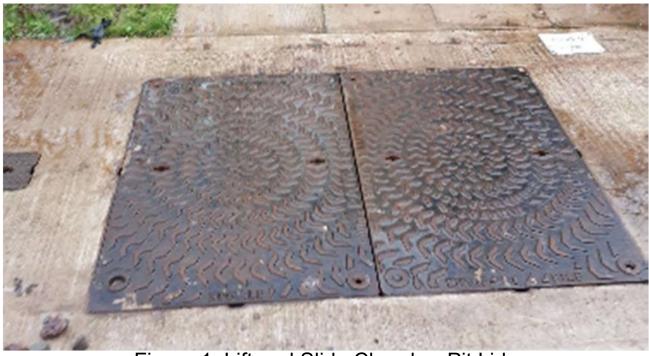
Figure 1: Lift and Slide Chamber Pit Lid

- Both the IP and the witness reported that the lid was stuck due to a possible ingress of water that had frozen and expanded creating a seal between lid and frame. The lids are designed to be a 'lift and slide' which necessitates the activity being undertaken by 1 person. No instructions for accessing the chamber were issued by the Scheme, however, the IP has been working on this Scheme for the past 12 months and has lifted these chamber lids on numerous occasions previously and was aware of the weight and the correct lifting procedure.

- The 'lift and slide' chamber lids are of an old design and are not the safest option available to Scheme Contractors when installing new infrastructure.
- The Smart Motorway Alliance have a working paper supporting the use of springloaded lids to remove the need for manual lifting and moving – these lids have already been installed on another section of the M6 by the same Scheme Contractor.
- Why were lift and slide lids specified at this location and spring loaded at others?
- The working paper states that a departure is required to be submitted to NRTS for us of lift and slide lids, however no record exists of one being submitted.

- Early NRTS consultation in preliminary designs. We are hopeful to have a specific note within RTB26 to prompt NRTS as a standalone contact, rather than being grouped within the 'stakeholder' category;
- Explore options which remove or reduce the requirement of 'manual handling';
- Spring loaded lids are the preferred NRTS solution however these may not always be feasible.
 Consultations with the correct contacts can eliminate the ned for re-work; will enable sharing best practice; will promote collaborative working which will ultimately de-risk the project;
- NRTS contacts for scheme/design consultation:
 - Neil.Brooksbank@telent.com (Regional Project Manager North)
 - Andy.Hopes@telent.com (Regional Project Manager South)
 - <u>Darren.Allen@telent.com</u> (National Highways Safety in Design Manager)
