Safety Alert Lighting Unit Fall Onto a Live Carriageway

8 April 2024

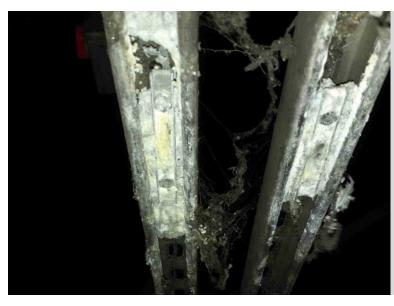
Whilst driving through the A27 Southwick Tunnel, a member of the public reported debris in the carriageway. Upon removal and investigation, it was found to be a tunnel luminaire which had fallen from the soffit bracketry. No reports of damage were made to vehicles or further infrastructure.

Images from site indicate the cause of the failure to be bimetallic corrosion due to incorrect material design between luminaire fixtures and soffit bracketry. The corrosion from the stainless steel and aluminium reaction is not thought to be an isolated event within this tunnel. Therefore, emergency works are being carried out to secure the luminaires as a short-term solution.

- Check that designs specify fixings that prevent bimetallic corrosion. This is not limited to luminaires or tunnel assets.
- Raise awareness of the need to inspect safety critical fixings and hidden defects.
- Review 'as-built' information, Operation and Maintenance Manuals and undertake inspections to confirm the information held on assets is accurate.

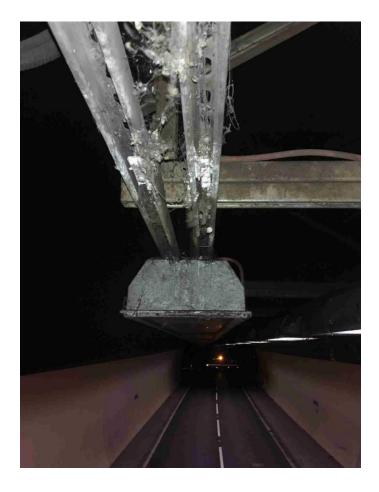
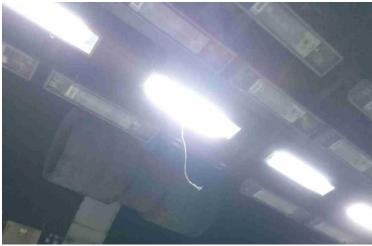
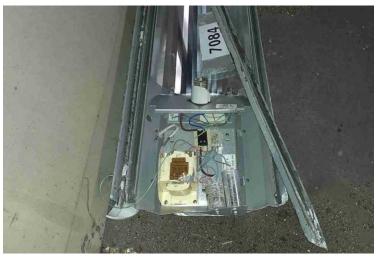
Additional images of the failed luminaire and the bimetallic corrosion
