Principal Designer Working Group

Root Cause Analysis – Capture & Application of Lessons Learnt

21st July 2022

National Highways H & S Alerts – Arcadis Summary

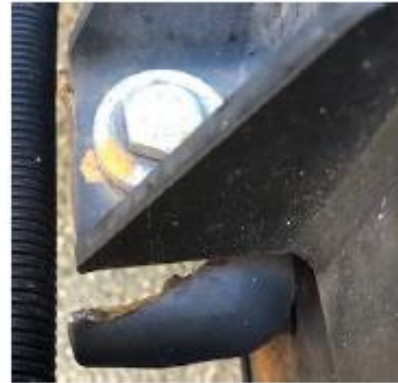
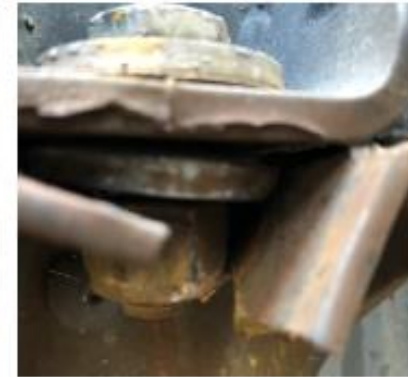
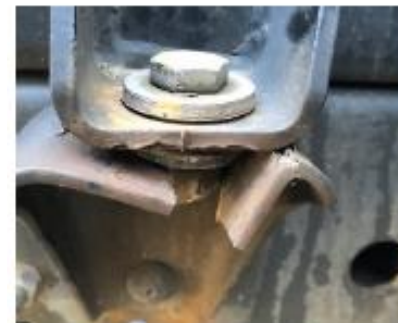
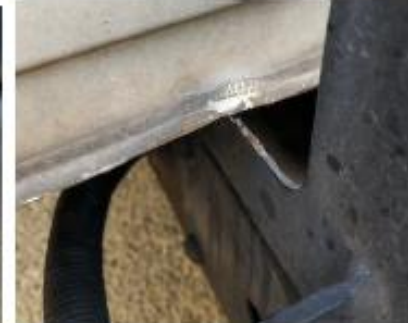
NHa296 – MEWP Hoist Potential Separation

- There should have been a pre-shift in addition to 6 monthly inspections under LOLER.
- The extent of the damage, with a number of fixings exhibiting severe cracking/ fatigue damage, would seem to indicate either that the MEWP had been abused or that pre inspection checks had not been undertaken as rigorously as might be desired.
- Raised with Project teams. Importance of pre-use checks
- Forwarded alert to Arcadis NEC supervisors to review with PC's.
- Is it possible there might have been a design fault with this equipment?

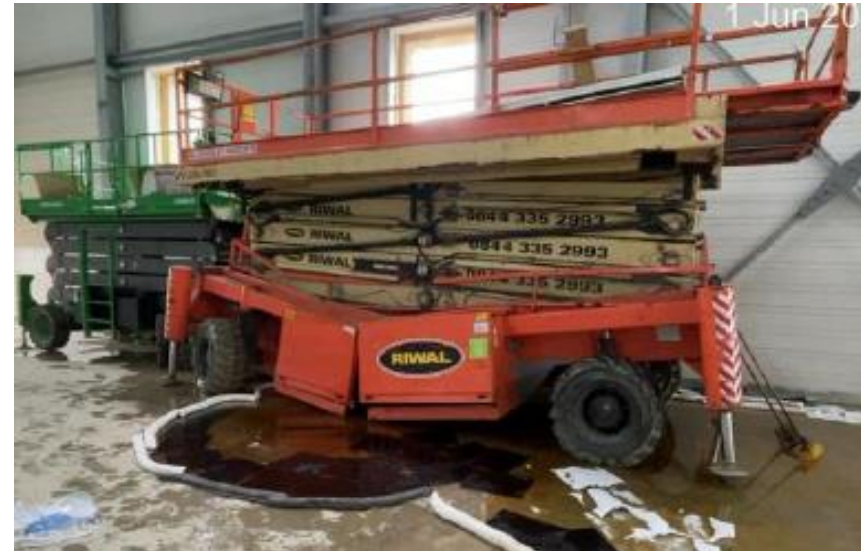
NHa299 – Catastrophic Failure of a Mobile Elevated Working Platform

- It is not clear why the MEWP didn't descend slowly from working level: it appears to have dropped to ground instantaneously.
- MEWP access is the safest option for the installation of cladding panels being undertaken here.

- This was a hired machine. Such machines do tend to get abused. Nevertheless it should have undergone a 6 monthly LOLER check and a pre-use visual inspection. A visual inspection might (or might not) have identified a hydraulic hose failure? There is no indication that any faults were identified pre-use.

- Check that a daily inspection has taken place. There have been numerous MEWP issues in recent past. On M4 outriggers were not extended when a failure occurred.

- All MEWPs of this type and manufacturer are to be removed from service immediately and formal inspections are to be performed by competent personnel in accordance with the manufacturer's instructions.

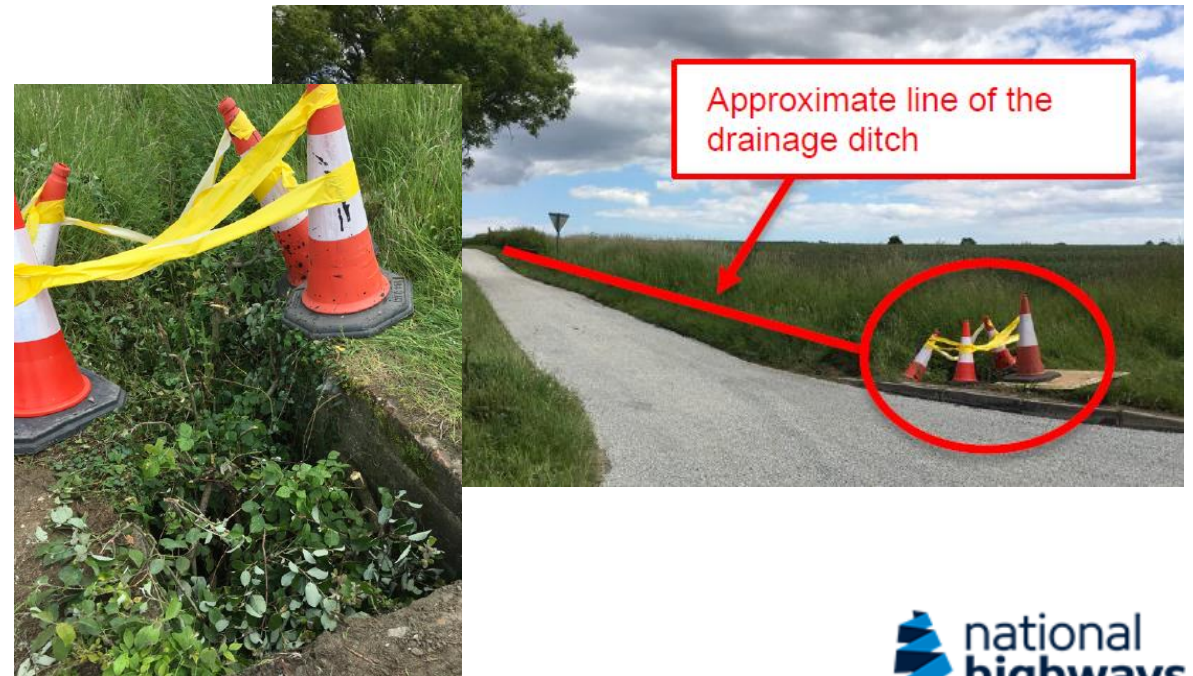
NHa300 – Working on Verges

- A visual inspection prior to start of work, and use of protection measures to any obstructions thus identified, noted within the site RAMS and briefed to workforce prior to commencement of works. These measures may have helped avert this accident. More frequent verge cutting would also help. Noted that this is now undertaken less frequently by councils, particularly on remote rural roads.
- Arrange for vegetation to be cut back and debris collected before any works on the verge commence.
- If working at night provide suitable task lighting.

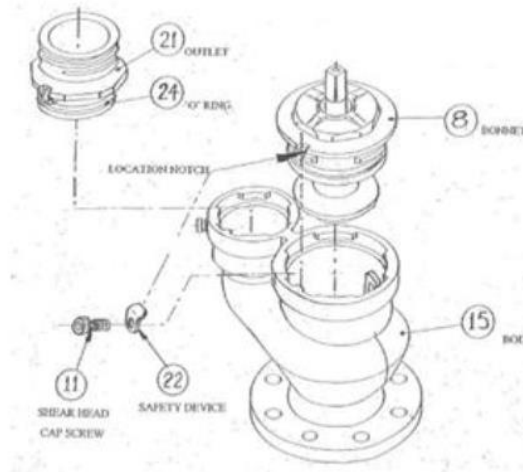
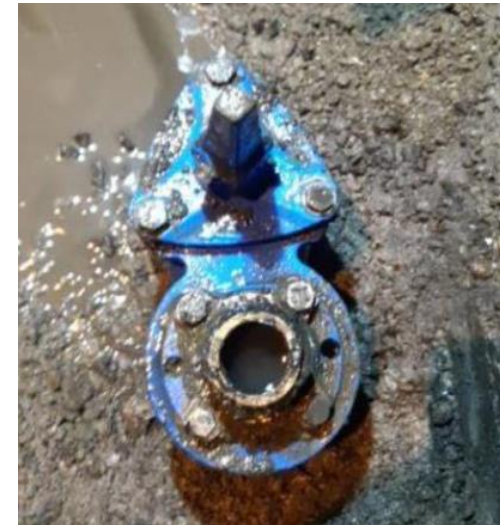
NHa301 – S19 Fire Hydrants – Immediate Stop of Use.

- Civils designers don't typically get involved with the design of hydrants. Water companies are responsible for providing hydrants, fire authorities for maintenance. This alert may be relevant to contractors who need to draw water from a standpipe occasionally for soakaway tests or the like. Hydrants are essentially a simple design: it is not clear why a single pin the sole ground fixing. Hydrants are required to be installed at certain spacings depending on the situation. Schools need at least 2 hydrants. Replacing a large number of hydrants in this way will be expensive. They are normally identified by an 'H' with the diameter of the main appended.
- Detail on how to identify a S19 Hydrant is detailed fully within the Safety Alert [Link](#)

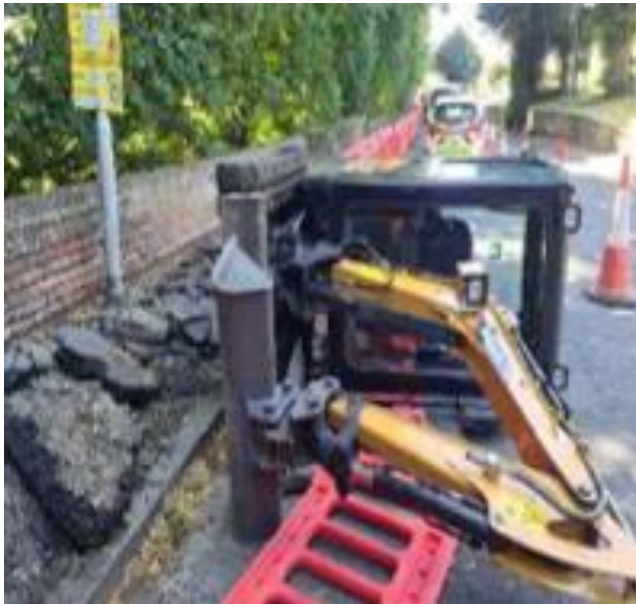
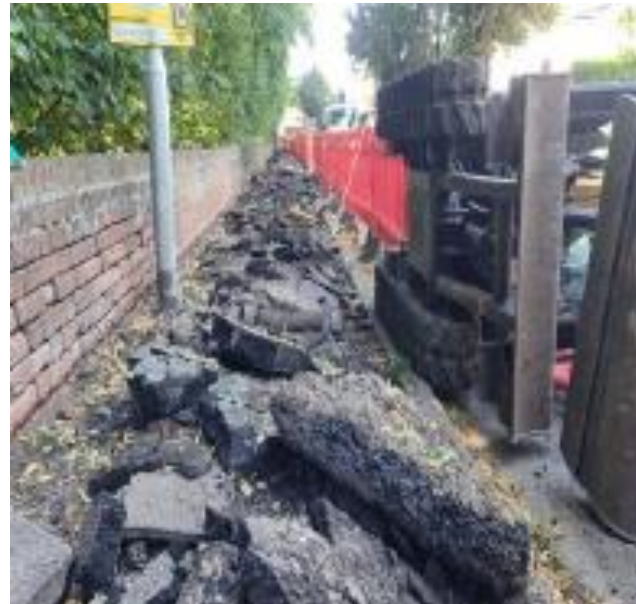
No. 011 – Ringway Infrastructure Services / Mini Digger Overturned

- It is not clear why the mini excavator was tracking on top of the broken up footway rather than the road adjacent to it. The 'B' road on which the works were taking place was of sufficient width for the excavator to track along it, next to the footway. There appear to be vehicles parked outside the barrier here, the working arrangement does not look to be well thought out. RAMS issue?
