## Smart Motorway Detached manhole covers

# SafetyAlert

25 September 2015

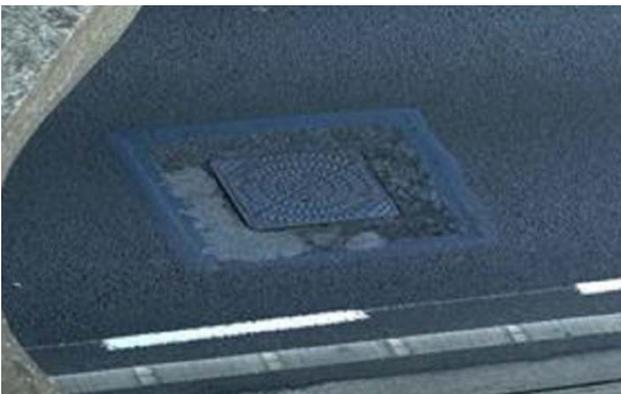
A manhole cover became dislodged from its frame within LBS1 of the M1 southbound carriageway; subsequently four vehicles then struck the cover. The cover pierced a lorry fuel tank leading to a diesel spillage. The second half of the cover fell into the chamber. Subsequently two further lids became detached causing damage to cars.

The manhole cover was made up of two triangular sections held together by a bolt. Subsequent investigation revealed defects to the bedding material below the frame and the bolt holding the two sections of the cover together had sheared.

The M1 motorway was running under long term traffic management at the time, causing the wheel track of vehicles to move from their usual position.

Surround to the manhole had been made with a proprietary bituminous repair material IKO Permatrack carried out during M1 10-13 widening. This had subsequently been repaired evidently with a different material. Further investigation is required in to the durability of the original material and the subsequent repair, either of which may be a contributory factor.

- IAN 111 guidance states *Clause 5.7 states: Manholes in hard shoulder should be avoided if possible, relocated or upgraded to D400/E600 standard.*
- It is therefore possible that similar circumstances exist on other smart motorways. Investigation should be carried out to establish if similar risks exist.

- Prior to switching traffic position under traffic management, investigation as to whether manholes would fall under the wheel track should be carried out, with appropriate risk mitigation

- Practical measures to reduce the risk associated with manholes in running lanes will vary to suit site circumstances, but could include welding of the manhole covers, although this alone may be insufficient if the bedding of the frame is compromised. Under such circumstances reducing the level of the manhole, plating and surfacing over the gap may be required. Such options introduce attendant maintenance risks, meriting a site specific risk assessment.

- Further technical investigation in to maintenance strategies for manholes in running lanes is required.
