Hard Shoulder Structures Inspection (M56) - Major Injury

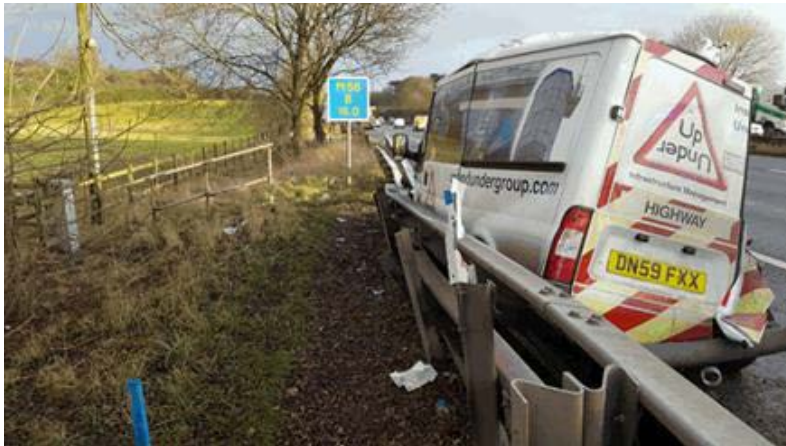
On the 8th December 2016, a structures inspector working on behalf of BBMM on the M56 (Area 10), re-entered their van from the passenger side after completing a routine structural inspection of an overhead sign gantry. The van was struck by a HGV tractor unit which moved from lane 1 onto the hard shoulder causing major injuries to the IP and significant damage to the van.

Immediate cause: Struck by a moving vehicle when a HGV truck driver who moved the HGV tractor unit from lane 1 to hard shoulder striking the parked van.

Root cause: Safe systems of work were not suitable or sufficient for short duration stops and the method statement failed to consider lower risk options as part of a hierarchy of control.

- Risk assessments must include suitable controls for parking on hard shoulders and off the network e.g. behind barriers, parking off the hard shoulder on the verge to allow for swift and safe access from passenger side.
- Ensure the adequacy of lone working procedures to ensure activities are controlled as far as is reasonably practicable.
- Ensure sub-contractor safe systems of work include all foreseeable risks and controls and are reviewed by a competent person.
- Ensure hard shoulder working procedures mitigate the risk to workers and road users.
- Establish a hierarchy of control for parking safely on or off the network and communicate to all workers.
- If possible consider information packs for workers with safe parking information for stopping on hard shoulders.
- Improve knowledge of risk assessment, through training; writing, reviewing and understanding.
