## Incident description:

A rebar cage for the central pier of a road bridge collapsed whilst under construction. Access to the structure for steel fixing was via scissor lifts and as the structure collapsed the red scissor lift was knocked over.

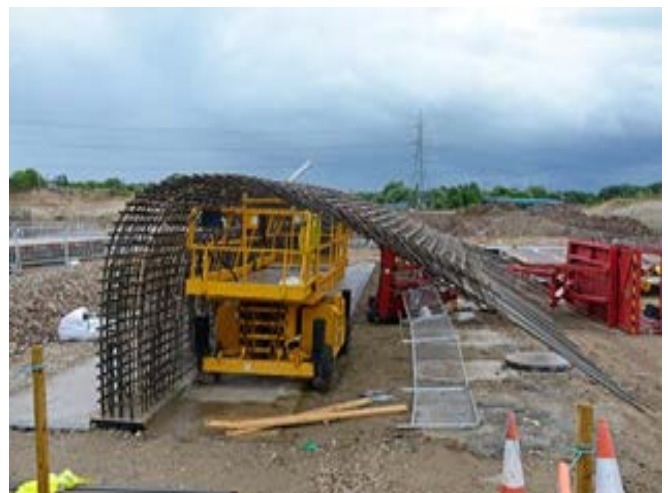
Two steel fixers working in the red scissor lift were injured in the incident. One suffered a broken ankle whilst the other sustained life threatening injuries.

- Incorrect engineering judgement led to misconceptions that the rebar cage did not need temporary supports/props. This decision was not independently reviewed by a competent Temporary Works Designer.

- The rebar cage was not designed to be free standing and collapsed when ad-hoc props were used to try and plumb the cage.
- The Temporary Works procedures were not explicit enough to ensure that the rebar cage received the necessary temporary works design and check.

1. Your contract has a formally appointed Temporary Works Co-ordinator with suitable qualifications, experience, skills and resource to perform their role.
2. Your contract Temporary Works Co-ordinator has received and read this alert and the Temporary Works Forum (TWf) 'rebar stability safety bulletin'. [https://www.twforum.org.uk/media/70138/tw15.116\\_rebar\\_stability\\_safety\\_bulletin.pdf](https://www.twforum.org.uk/media/70138/tw15.116_rebar_stability_safety_bulletin.pdf)
3. Your organisation has a mechanism to share lessons from incidents and good practice with the Temporary Works Co-ordinators throughout your whole business.
