Global Safety Stand Down (GSSD) Briefing for worksites

GSSD Dominik Rychert Crushed in Trench Collapse

Location: DW 222 Gdańsk – Starogard Gdański,

Date of accident: October 2 2018

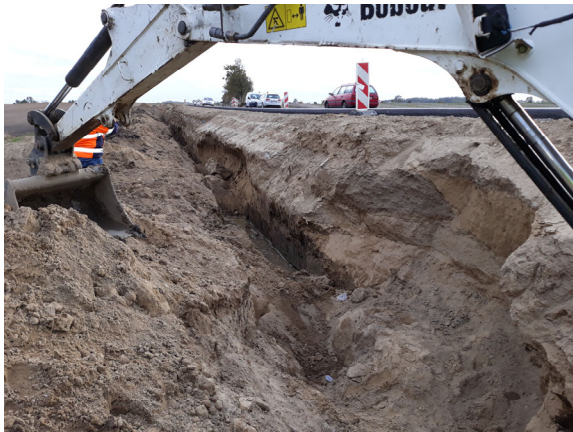
The likely hypothesis is that he was walking back to his machine along the top edge of the excavation at the side of the road when the ground gave way and Dominik fell into the excavation and was buried. The exact details of how he came to be in the trench may never be known..

Location of the trench side collapse

- Trench collapse

- All Skanska Poland worksites were closed for safety reviews.
- Reinforcement of the Skanska procedures including procurement of contractors and pre task planning and pre task briefing.

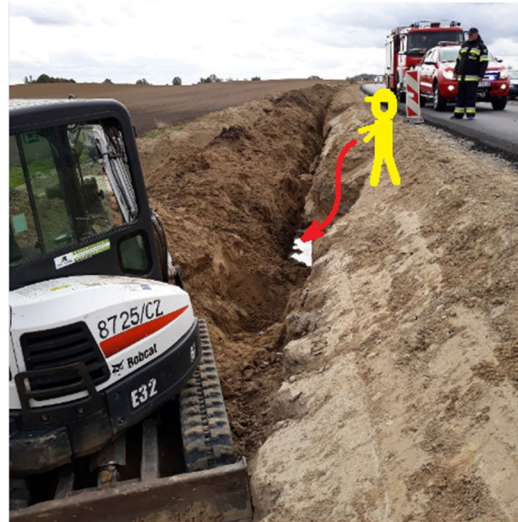
Position of trench collapse where Dominik Rychert was trapped

- No pre-task planning was done prior to starting the work and there was no method statement detailing how the work was to be undertaken. There was no agreement as to when to stop work if site conditions changed such as the depth of the cable changing or the ground becoming less stable.
- The procedures for selection and appointment of contractors was not followed.
- Energy Works Manager thought this additional work could be done quickly and would deliver increase profit on the project.
- The section manager did not participate in the planning and coordination meetings for this work.
- Dominik was working alone at the time of the accident.
