# HiPo: Lifting operations

# Potential LTI: Back injury

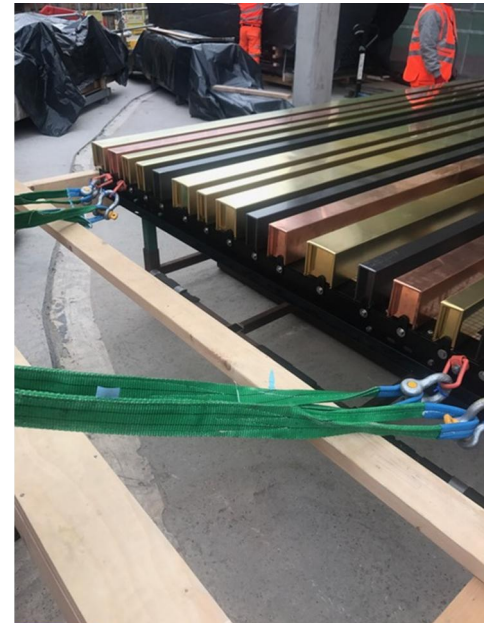
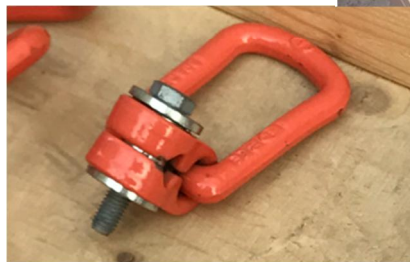
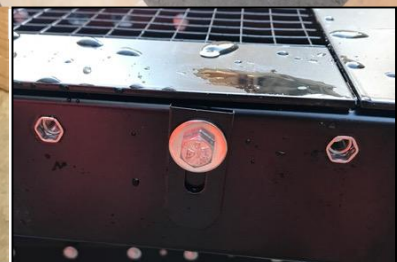
On the Major Projects, Crossrail C512 project, while lifting mesh cladding panels, the rivet nut sockets into which the lifting eyes are screwed popped out from the steel frame.

A mesh cladding panel was being lifted from its assembly point using four lifting eyes located at one end of the panel. When the cladding panel was in the vertical position and approx. 100mm off the lifting table, two of four rivet nut sockets popped out of the panel frame and one side of the panel dropped to the assembly table.

The load was immediately lowered and returned to its horizontal position – when it was near horizontal, the remaining two rivet nut sockets also popped out.

Exclusion zones were established and no operatives were injured and there was no damage to infrastructure. 37 of 161 panels had been installed by the same method; this was the 38th panel.

A full investigation has commenced.

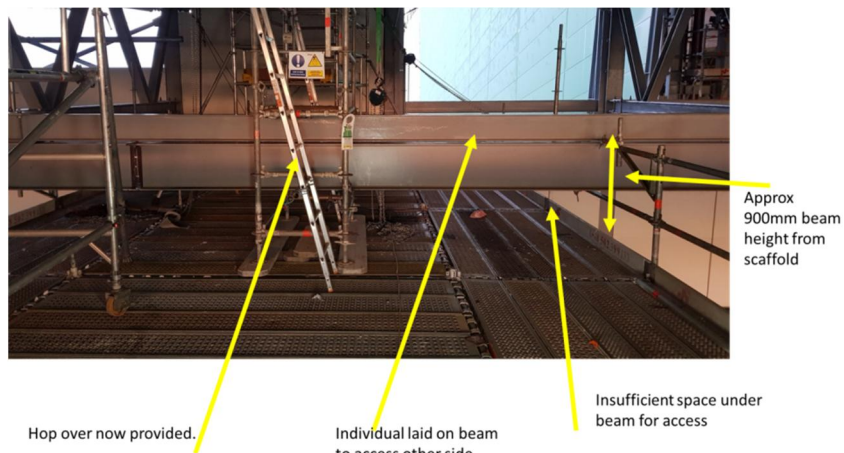
On the Major Projects Gloucester EFW project, an operative allegedly suffered back pain when he was climbing over a steel beam (at low level) and slipped.

An operative was crossing over a beam (approx. 60mm deep and 900mm high) and as he swung his leg over, he caught his leg, slipped off the beam and hurt his back. He was sent home and seen by his local hospital, but no-one from his company has managed to get hold of him since.

We are awaiting further information. A scaffold hop over has now been provided, as shown in the photograph.
