### Issue

#### Modification of Modular Designed Gantry

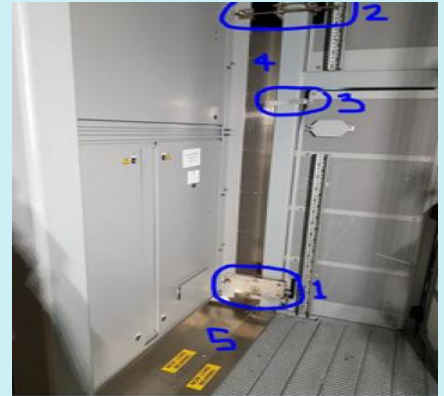
- Structural alterations incorporated
- Additional live load access added
- Non load bearing members incorporated
- Structural fixings wrongly installed
- Damage incorrectly repaired
- Lack of communication between designers
- Technical Approval Process not followed

Ensure that the original Technical Approval (TA) documentation is reviewed and that there is a full understanding of the original design brief, loading arrangements and expectations for O&M. The Principal Designer (PD) should ensure that the lead structural designer coordinates the analysis of all design changes, amends the TA documentation and obtains TAA sign off for all new/modifications for the design changes proposed.

PC to liaise with the PD to ensure that the lead designer has obtained TAA sign off and that any subsequent PC led onsite design delivery has followed due processes.

MSP to ensure that all inspection, operational and maintenance related activities are in accordance with the Design Risk Assessments and the documentation produced by the design team signed off by the Technical Approval Authority.
