PDWG Task Group – Safety Shares

Summary on a page

Purpose of the Meeting - to investigate whether a Design Close Calls process similar to that used by Network Rail might provide learning and sharing benefits for health, safety and wellbeing considerations for the National Highways community

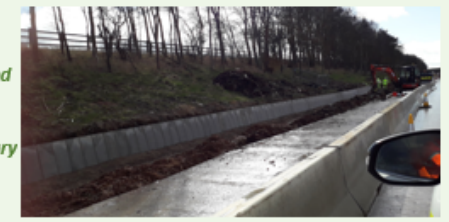
A19 Norton to Wynyard had a requirement for low height retaining walls along the north and southbound carriageways. Over-excavation of the slopes along the A19 posed a significant risk of slope instability during the temporary works phase. Flag on edge was utilised as a solution.

Although mechanised lifting was originally specified, with 1000 x 600mm slabs to be used, actual site access restrictions meant that hand installation of the flag on edge was required. Smaller 300 x 600mm slabs were eventually used to reduce the extensive manual handling.

The use the smaller slabs would mean that they would be more easily replaced; however, the increased number of joins would increase potential water ingress and weed growth.

Working area had not been considered during design development. Alternatively, a pre-cast L section, or TCB, could have been substituted for the flag on edge. This could have been placed mechanically and backed up with concrete. There would have been a considerable reduction in manual handling, a reduced duration of the works and consequently this would have limited the exposure of the workforce to injury; and also enabled the TM to have been removed earlier reducing the impact on the travelling public

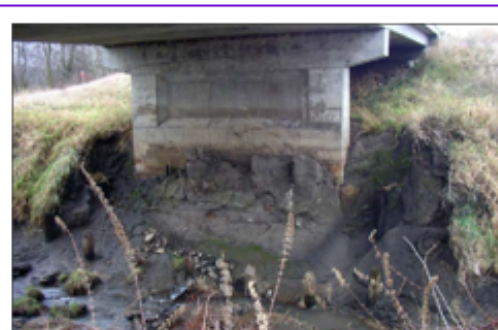
A designer has specified a block paving finish for a bridge revetment

- Constructing, maintaining and inspecting a bridge revetment may expose workers to tripping on uneven ground hazards, slipping and falling on slopes with an assessed residual risk of an almost certain likelihood of minor harm and a may happen likelihood of moderate harm being incurred.

Photo of a bridge revetment without surface stabilization treatment

- Design bridges without sloping revetments.
- Specify revetment with a hard landscaped finish.
- Evaluate block paving with sprayed concrete solutions.

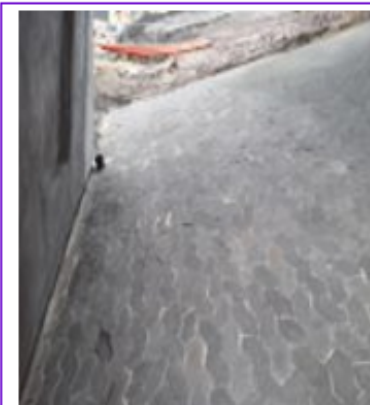
Photo of a bridge revetment with block paving surface treatment

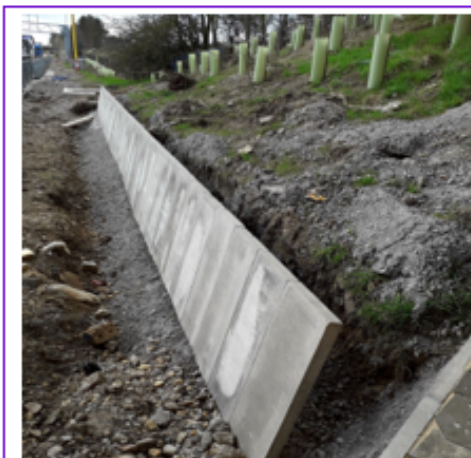
**Description of Event***A flag on edge solution was designed as a low-level retaining structure***Population at Risk**

- Construction of low-level retaining structure using flag on edge that requires manual handling with an assessed residual risk of 'an almost certain' likelihood of extreme harm being incurred.
- A flag on edge retaining structure has a shorter design life than other solutions, increased construction period and requires a shorter interval between inspections.

Photo of flag on edge retaining structure

- Eliminate manual handling of materials by designing a pre-cast concrete panel solution that requires mechanical handling.

- Ensure mechanical handling option is used.
- Minimise TTM requirements.

- Periodically assess safety and serviceability of retaining structures in accordance with CS459.
- Submit Works Request and raise safety observations.
- Design a suitable TTM solution before working on live carriageway.

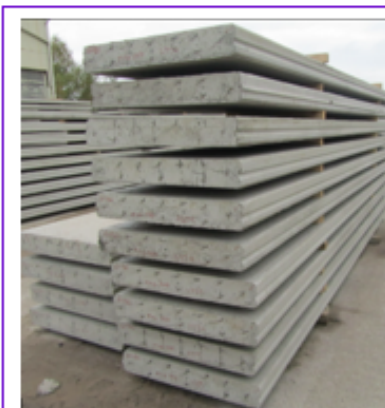
Photo precast concrete panels

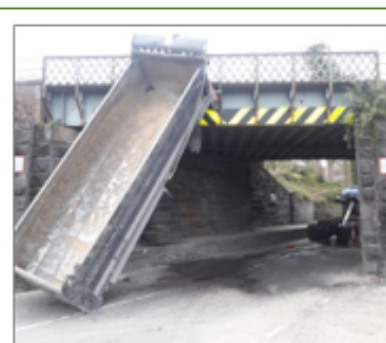
Material delivery location in proximity to overhead structure.

- Driving off with Tipper Lorry in unsafe condition
- Tipper lorry operations in close proximity to overhead structures with an assessed residual risk of an almost certain likelihood of major harm.

Photo of wagon having hit bridge deck with tipper body dislodged and resting on road and against the rail edge beam.

- Confirm that there are safe road access and egress routes to the site and that these are highlighted in the PCI.
- Material delivery or storage areas within the site should be considered within the PCI and sited at locations where safe access can be gained.
- The location of warning devices e.g., goalposts should be considered in the PCI.

- In this instance the process was changed for the acceptance of delivery tickets. Tickets could not be signed off by the site team until the delivery vehicle had been inspected and deemed safe to leave the site.
- Additional checks were introduced to ensure that the vehicle was safe to join the carriageway after delivery/offload of the materials.
- Temporary goalposts could also have been provided dependent on the location of the structure in relation to the site.

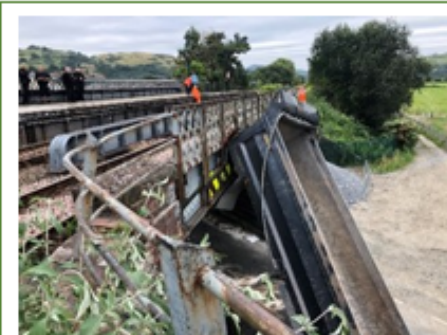
Photo of tipper body having collided with bridge deck. Rail bridge was shut until structural inspections could take place to ensure track and edge beam were undamaged.

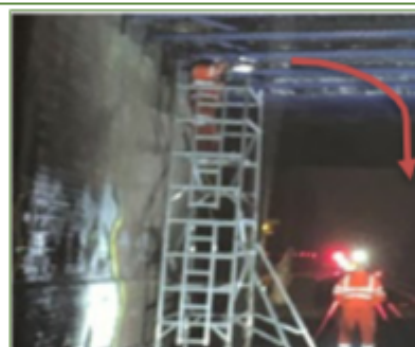
**Description of Event***Principal Contractor and Designer required work to be done at night. They did not consider how lighting may be secured to a scaffold tower.***Population at Risk**

- Working below temporary scaffold.
- Working at night with unsecured lighting equipment on scaffold towers has an assessed residual risk of an almost certain likelihood of minor to moderate harm.

Photo of worksite, tower on left was where the light fell from

- Provide a safe working area by specifying exclusion zones around mobile scaffold towers.
- Ensure the Principal Contractor provides information and instructions for workers on working at height. All working at height should have a specific Risk Assessment and Permit to Work.
- Toe boards to be specified in design in accordance with PASMA guidance.

- Always request toe boards to be fitted when there is a risk of materials/equipment falling from height and ensure exclusion zones in place.
- Consideration should be given to whether it was necessary to carry out the work at night. If not, this would eliminate the need to introduce an additional light on the scaffold tower. Ensure all attachments are suitable fixed and secure

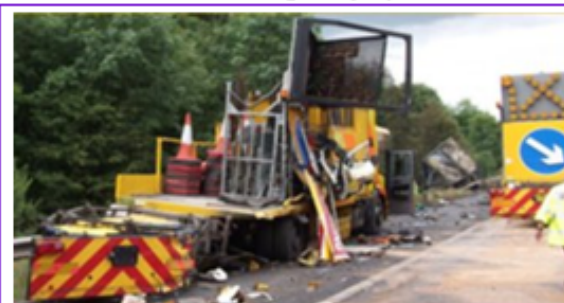
Photo of an Impact Protection Vehicle following a vehicle strike

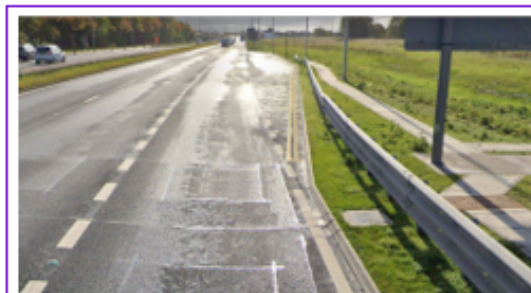
A designer has positioned assets (a traffic loop box) on live carriageway side of vehicle restraint system

- Live carriageway working exposes workers maintaining and inspecting assets to the potential of being struck by a Member of Public (MOP) vehicle with an assessed residual risk of an almost certain likelihood of extreme harm being incurred.
- A low load class of an asset cover is a hazard to vehicles driving on the shoulder with an assessed residual risk of an unlikely likelihood of minor harm being incurred.

Photo of a traffic loop box on live carriageway side of vehicle restraint system

- Provide a safe working area by positioning assets set back from a suitable vehicle restraint system.
- Provide information and instructions for workers on load class of cover and safe route from maintenance vehicle to working area within a Maintenance and Repair Statement.

- Submit Works Request to provide a safe working area and raise safety observation.
- Design a suitable TTM solution before working on live carriageway.

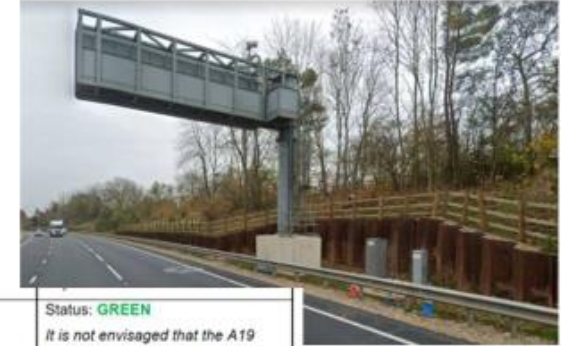
Handover (**Now**): One of the MS3's is pictured.

- Sheet pile too close behind barrier
- no steps down from verge, behind,
- no path from repositioned layby down the road.
- Handover certificate excerpts above stated “it is not deemed that Incident Management requirements are greatly different to existing” GREEN status.
- No residual risks identified in the H&S file information.
