## Title description: Reportable injury – Contact with hydraulic arm of HIAB

**A site operative (IP) sustained a cracked bone, flattened at the top, in Left Wrist – Injury sustained on Fri 10 Apr 15**

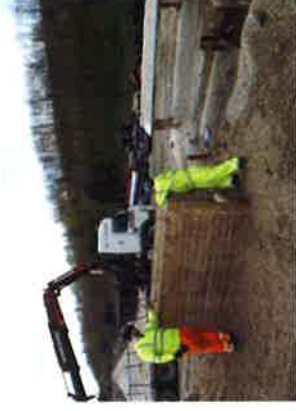
Re-enactment photo 1 –

Where IP was stood in relation to the Trench Box at the time of injury

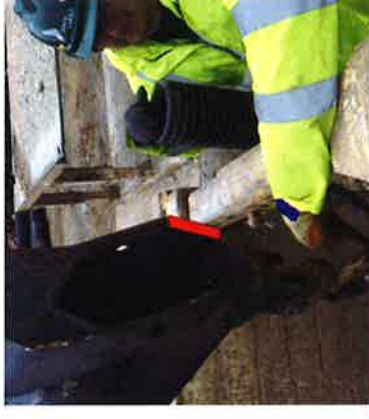
Re-enactment photo 2 –

- The speed of this unexpected action by IP caught the HIAB operator by surprise. A consequence of which was the crane hook effectively punched the top of IP's Left Wrist (beneath position of a wrist watch), before the HIAB operator could react, by stopping the operation/ retracting the hydraulic arm.

Position of IP's Left Hand and Arm, and part of the jib (coloured red) that made contact with IP's Wrist (coloured blue)

- **Assigning** - a trained Slinger/Signaller with each HIAB operator (mechanical lifting / lowering operation)
- **Hold point** - Safe system of work (SSOW) documentation in place for mechanical lifting and lowering using mobile plant equipment to include a "hold point" prohibiting works unless a trained Slinger/Signaller is in place
- **SSOW to include** - controls to prevent mistaken and unauthorised access into work areas when mechanical lifting and lowering operations are being prepared and undertaken
- **Trained Slinger/Signallers** - must be fully briefed on SSOW in place for each task prior to commencement of mechanical lifting / lowering, with briefings delivered by personnel, who supervise the works to be carried out
