SAFETY LEARNING NOTE

LESSONS LEARNED: FATAL ACCIDENT AT LANGLEY GREEN

Following a fatal incident in late 2013 at the Langley Green project, we have reviewed the circumstances of this incident and the key findings and recommendations are as follows:

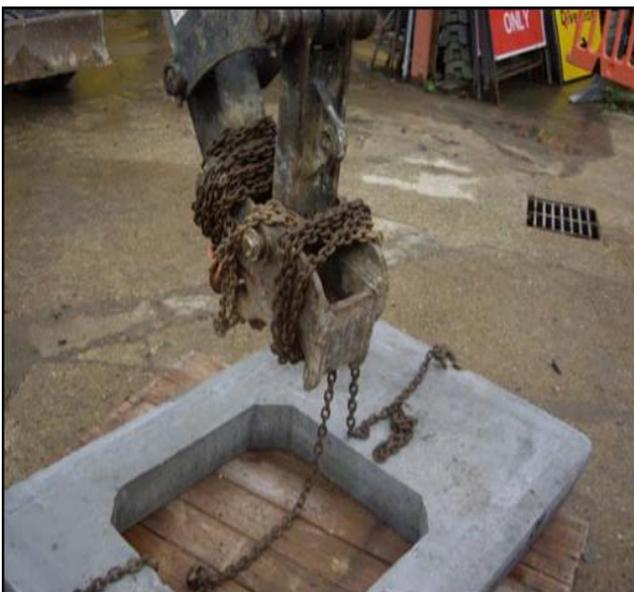
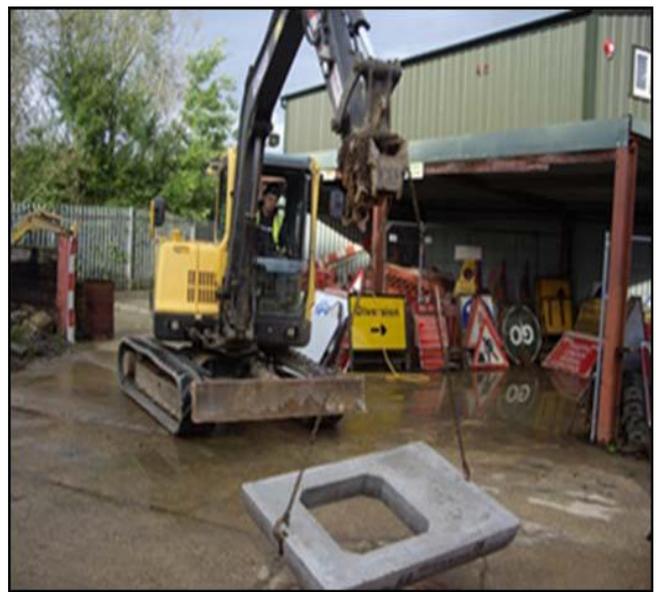
- The use of inappropriate lifting accessories; the chains used were too long for the task.
- The chains were not attached to the approved lifting eye on the excavator arm; they were wrapped around the dipper arm bucket attachment. This is likely to have led to them working free and destabilising the load.
- An exclusion zone was not established; the operative was located within the danger zone of the lifting operation and the operative was not a slinger signaller.

THESE PHOTOGRAPHS WERE TAKEN AS PART OF A REENACTMENT

- Vigilant reviews of sub-contractors' competencies.
- Ensure Work Package Plans (Method Statements) are suitable and sufficient and can deliver a safe system of work for a specific task and location; not generic.
- Ensure that the Work Package Plans (Method Statements) have been briefed to the operatives completing works via Task Briefing Sheets.
- Ensure plant and associated equipment is fit for purpose and in good order.
- Ensure exclusion zones are in place and clearly demarcated.
- Ensure sub-contractors provide suitable and sufficient supervision for their works at all times.
- Regular and clear communication with sub-contractors from the commencement of the project and throughout the period of their work activity.
- Provision of a minimum level of Balfour Beatty management and supervision for our works at all times (min 1 x SMSTS at any time whilst works are being carried out)
