**Cable Strike– Albert Embankment
Tideway Integration Group (TIG)
John Murphy & Sons (JMS)
12th January 2017**

Incident type:	HV Service Strike
	Safeguard Incident No:	6874306
	Incident Date:	12 January 2017 (09:45 hrs)
	Location:	Albert Embankment
	Injured persons:	Although not physically injured, JMS are supporting for any potential psychological trauma effects
	Area or Company:	John Murphy & Sons (JMS) Tideway Integration Group (TIG) Site
	Current Condition:	Cable is being repaired by UK Power Networks (UKPN)
	Incident:	HV Service Strike
	Current Situation:	Initial JMS statement has been provided via the JMS 212 reporting process, Initial Incident Report has been submitted and uploaded on to RIVO Safeguard. Investigation on-going

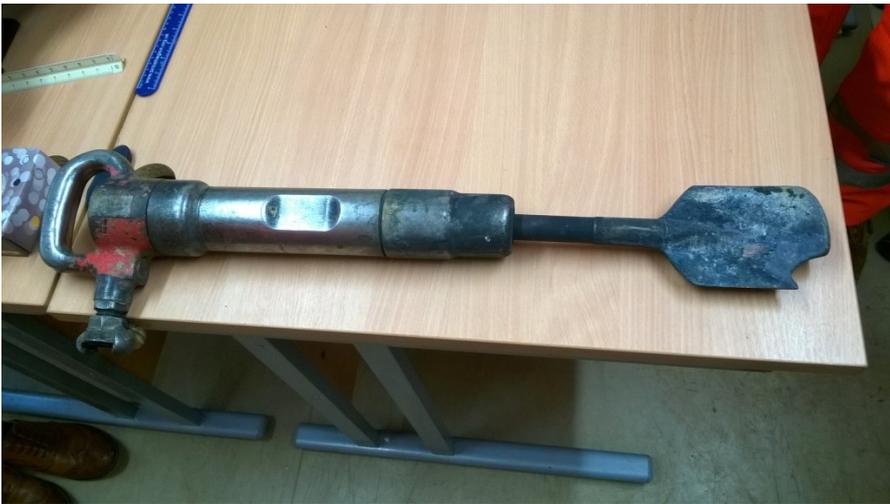
(Damage to clay spade)

- Operative slipped whilst using an FL22 hand breaker which made contact with a live HV cable causing an explosion and flashover.

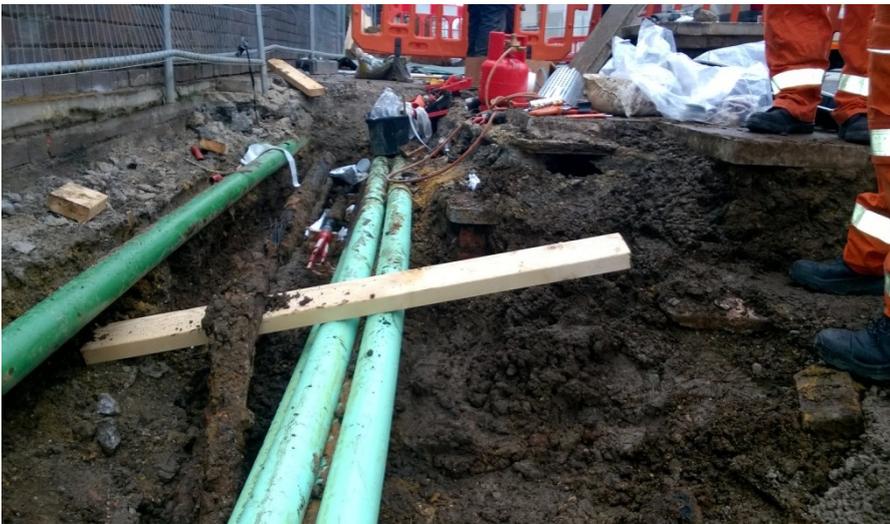
to chamber right of ducts)

(Showing restricted work space due

- RAMS did not identify restricted work space at incident location due to an adjacent chamber.
- RAMS were not explicit on the methodology / tools required to break out the cast iron pipe.
- Electric cable was not physically protected from damage.
- Site supervision observed the work activity but did not challenge the unsafe act.
- The operative being distracted by previous day's events to his colleague and friend.
