Business:	Construction Services		BULLETIN
Title:	TOPIC OF THE MONTH – ACTION BULLETIN	Reference No:	CCS/TOM/.....
Issue Date:	April 2015	Issued By:	Heads Of IMS
Type of Bulletin:	Health & Safety		
Subject:	Descending from Plant		
Who is affected:	All plant operators drivers and people working on plant/vehicles

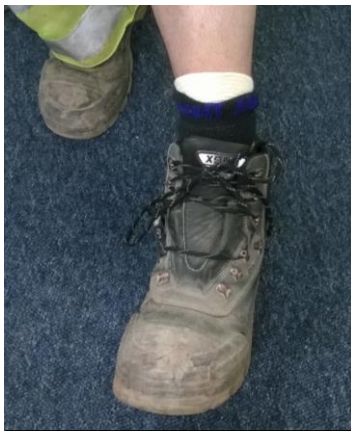
Missing laces reduce ankle support
