CCTV Mast Failure

Safety Alert

November 2018

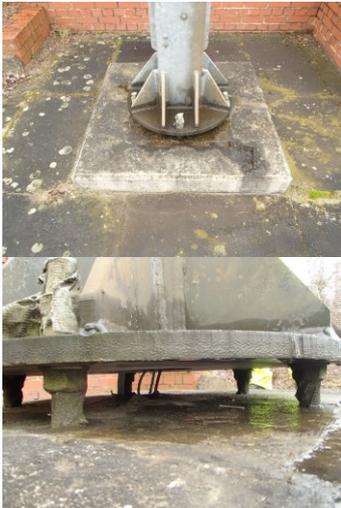
CCTV similar installation

CCTV Holding down arrangement

The holding down arrangement consisted of ungrouted bolts and with the base of the mast set on levelling nuts.

Inspection of the mast indicated progressive failure of the holding down bolts. Failure has occurred over time (see photograph of a corroded bolt). Greased tape corrosion protection was evident above the baseplate but not below where the bolts have corroded and failed. This area would be difficult to inspect.

- Structures assets are recorded on relevant databases; and
- Structures are maintained using Highways England's Standards and Asset Management Procedures.

Inspections should be undertaken by competent employees and in accordance with [BD 63/17](#).

Consideration should be given to the integrity of vulnerable details including holding down systems, bolt tightness and effectiveness of corrosion protection measures.
