Safety Alert

Jerol Lighting Column Sheath Fault

13th February 2019

Area 12 Safety Alert

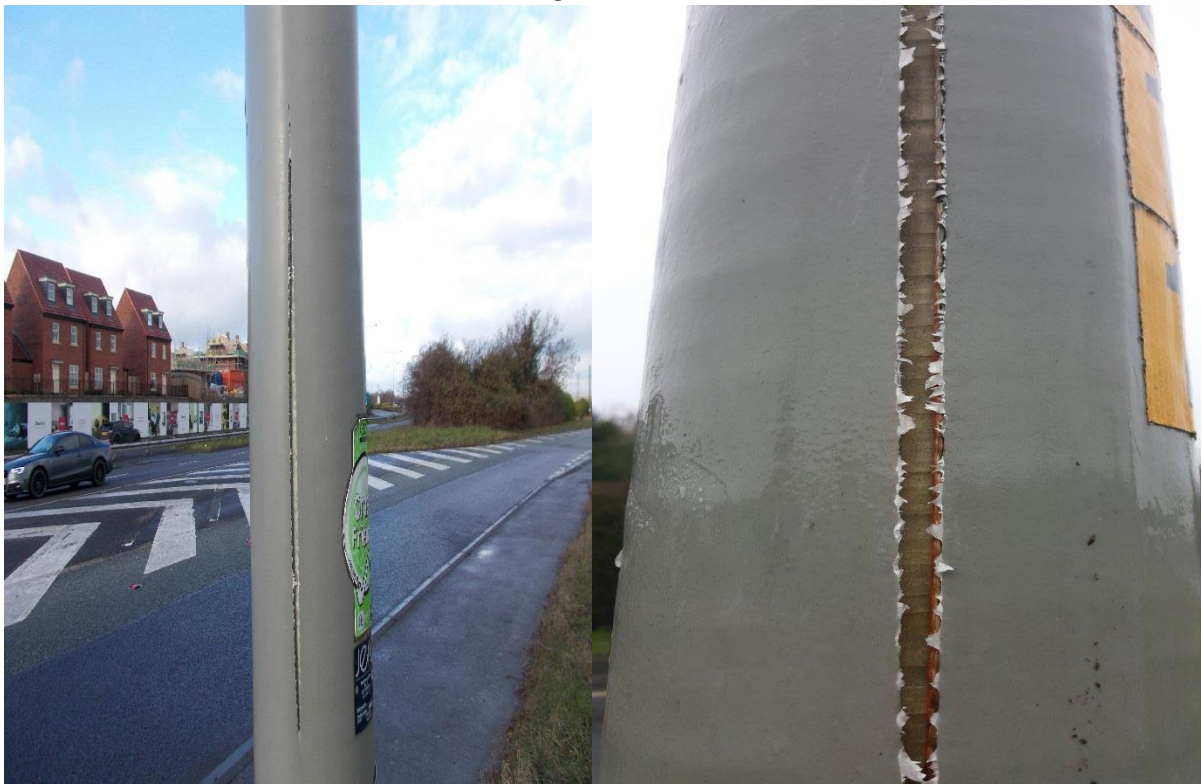
Fig 1

A Safety Alert relating to the splitting of the outer sheath (Fig 1) of composite type passively safe lighting columns manufactured by Jerol.

Routine inspections identified an issue with the outer sheath of various composite type lighting columns which were found to have split along the length of the column shafts. The splits varied in length with some at the top end of the column and others had the split running the full length of the column.

Our records show that the columns have varied manufacturing years, so this issue is not unique to a specific batch.

All Jerol lighting & sign stock is being inspected. Any identified failure is to be evaluated for structural integrity with any recommended mitigation measures undertaken which may include removal of the column off the network.

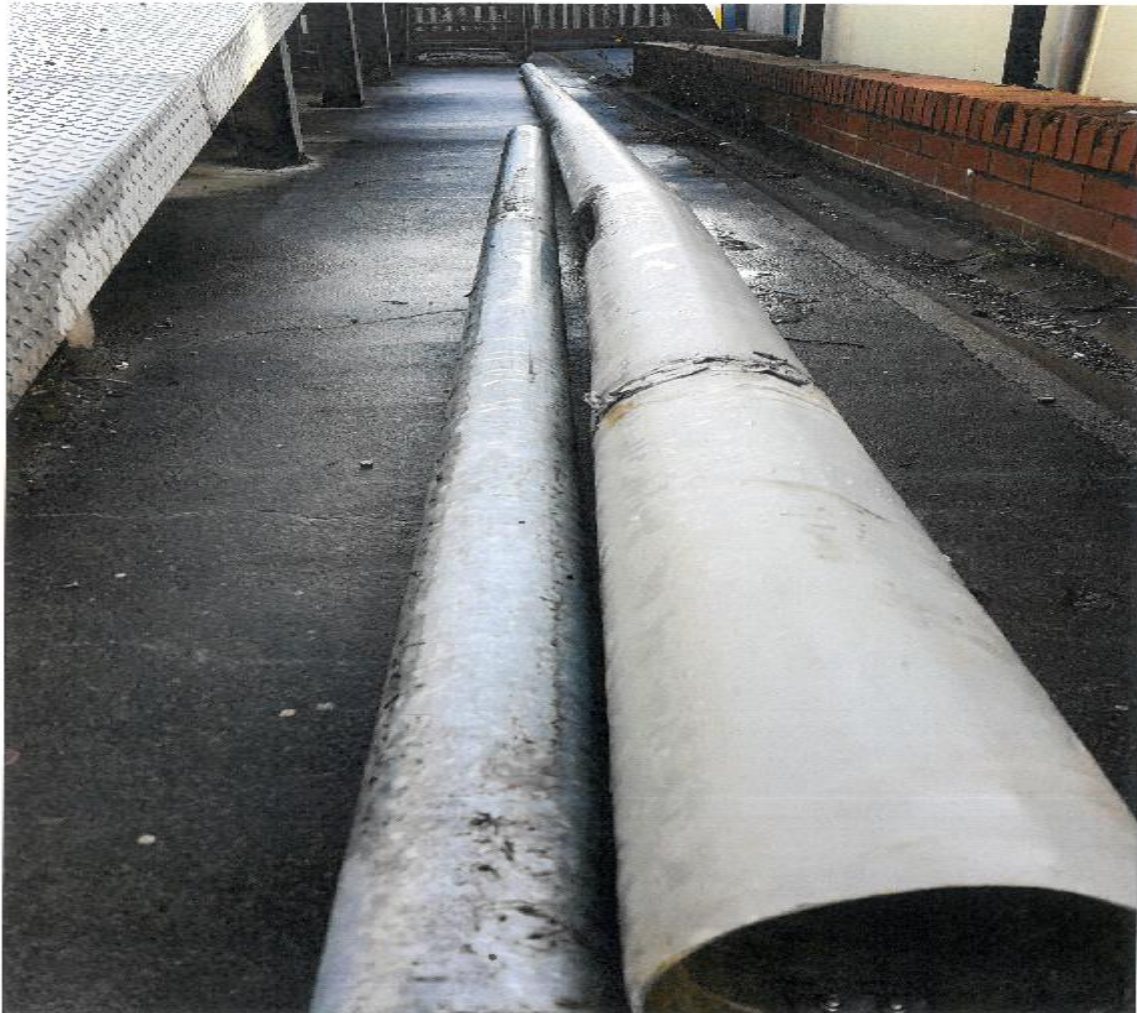
Fig 2

In addition to this we have also found one column to have extensive bowing with creasing of the internal structure (Fig 2)
