# Safety Alert

## Trailer Rolling off Low-loader

# Trailer Rolling off Low-loader

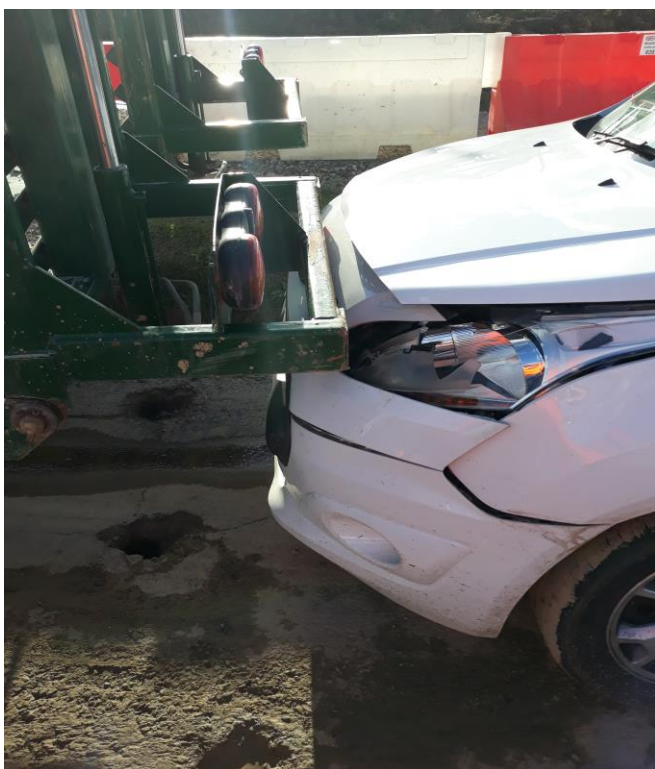
Photo below shows the resting position of the Trailer after impact with the parked site van.

At this point, due to the back of the trailer being situated on the lower part of the low-loader ramp the weight transferred lifting the trailer draw bar ring off the hook resulting in the trailer rolling off the ramp onto the access road and into a parked van approx. 30ft. behind, causing damage to the bumper, bonnet and light of the van.

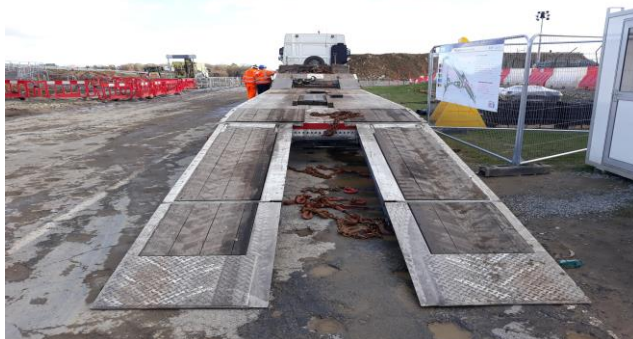
Photo below shows the Low-loader which the Trailer rolled off once disconnected from the tractor

The Tractor Operator manoeuvred the Tractor and Trailer onto the Low-loader under the guidance of the Low-loader Driver. It became apparent that the trailer was over-hanging, so to create more space the trailer was disconnected from the hydraulic tractor brakes and the tractor hook by the low loader driver.

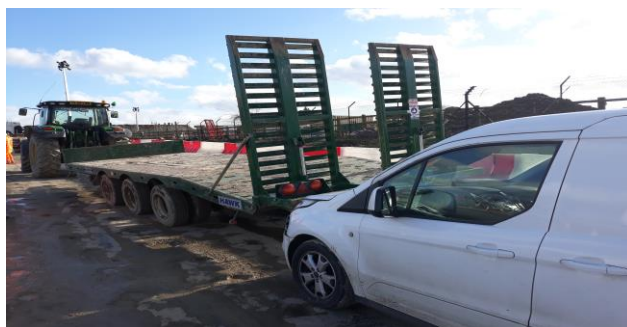
Photo below shows the full length of the Trailer and the Tractor that it was disconnected from whilst on the Low-loader.

- There was an assumption made by the Tractor Operator that when the hydraulic brake hose was disconnected from the Tractor, it would engage the Trailer brakes.
- The manual brake handle wasn't identified during the Operators pre-use checks on the Trailer during the pre-use visual inspection.
- Lack of clear process for undertaking reasonable checks before Low-loader operations commenced.
- The Low-loader was not long enough to hold the Tractor and the Trailer whilst connected.
- The Operator did not hold a Load and Secure competency card.

- The incident was reported to site management who made the scene safe and initiated the investigation process.
- Any activities involving the delivery or collection of plant were ceased until the site process for managing this type of activity was reviewed and re-briefed to all concerned.
