# Safety Alert

## Lighting Column Falling from Lorry Loader

17<sup>th</sup> April 2019

**J McCann & Co Limited**

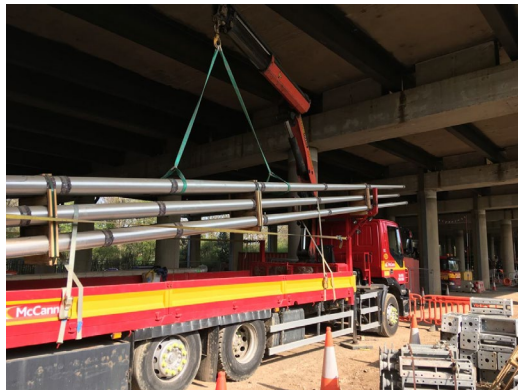
The lorry was driven out to site and positioned at the first column location. The operatives released the ratchet straps holding the pack down to the lorry then cut the banding holding the pack of 9 columns together.

The first column, top of the 3x3 pack towards the centre of the lorry, was slung and lifted off the pack in accordance with the approved lift plan. Once clear of the pack the operatives re-secured the remaining lighting columns to the lorry with the ratchet straps. As the ratchet was being tightened at the side of the lorry, the top outside column rolled from the pack, hitting the IP on the soft tissue of their left thigh.

The columns were loaded onto the lorry loader as packaged by the manufacturer, whilst it was initially loaded safely and retained by the H frame, no consideration was made for the columns becoming separate elements after the banding around the column pack was cut.

This led to single columns being accidentally stacked above the H frame and being able to fall.

- 3x3 packs of columns will be split on the floor before being taken out to site.

The banding of the pack will be cut and re-banded using a banding machine in to a block of 3x2 and the top row of columns removed one at a time using a sling and the lorry loader crane and placed on to the offside of the lorry loader bed.

- The pack will then be lifted on to the bed of the lorry loader using the lorry loader crane and placed on the nearside of the bed and secured for transit against the nearest vertical bar of the H frame using two ratchet straps.
- All our column and post suppliers have been contacted and instructed that delivered packs of columns and posts are not to be more than 500mm high to ensure the height of the pack, does not exceed the vertical height of the retaining H frame.
