Safety Alert

Crack Identified in MS4 Mounting Bracket on M42 Portal Gantries

21st June 2019

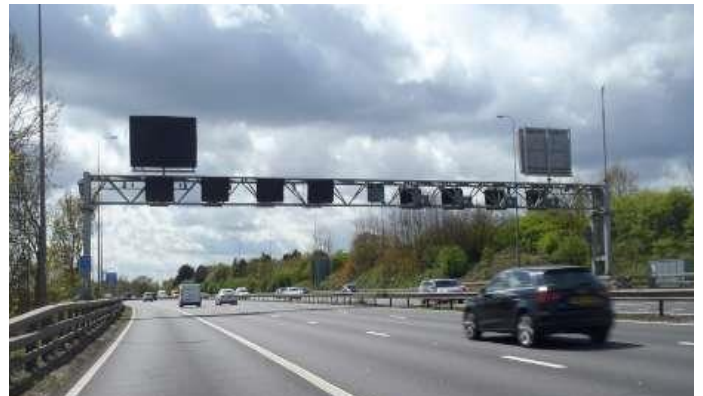
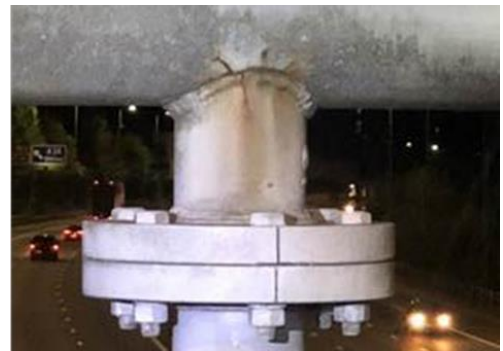
On 22 May 2019 one of our maintenance contractors working on a portal gantry over the M42 spotted a crack in the support bracket of a MS4 sign, located on top of the gantry.

This crack was inspected by the Area structural engineers and the decision taken to remove the sign to manage the risk of the crack progressing rapidly in high winds.

A further 10 MS4 sign supports were identified with similar defects and subsequently removed.

The defects are currently being investigated and tested to fully understand the root cause. The key concern is that the support relies on a single connection, with no alternative support should the weld fail.

- Area teams and inspectors should be aware this concern and where similar details are present, thoroughly inspect the welds for signs of cracking during Principal Inspections.
- Where possible, Designers should seek to avoid replicating this detail and look to introduce secondary support connections to provide a failsafe safe design.
