# Safety Alert Service Strike

12 August 2019

## **Learning From Incidents**

Injury Type: Service Strike Date: 09/07/2019

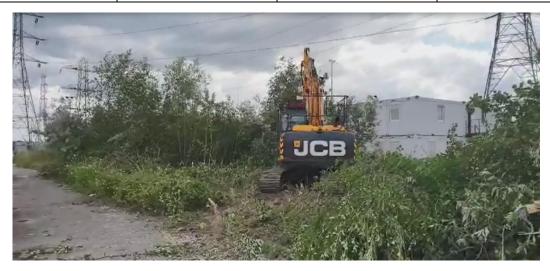
On the 2<sup>nd</sup> July, at approximately 15:35, a service strike occurred when an excavator tracked over an above ground 415V armoured cable. This cable was located in the vegetation clearance area of the satellite compound in Ingrebourne Valley. The excavator (with a grab attachment) was completing vegetation clearance works for site compound set up.

The service strike caused immediate loss of power to the neighbouring site welfare cabins of Brown and Mason. Following the strike the excavator operator stayed in the cab and called for assistance. Brown and Mason representative and their electrician were called to the scene and confirmed power had been lost and the area made safe. The excavator driver was then able to track back to safety and stand down.

The power was supplied by a generator situated in the work area of Package B. Perfect Circle and Socotec Site Management believed the area was free from services. They had received a guidance certification from the site owners which was misunderstood and heavily relied on. The certificate also failed to mention the power generator.

Failure to follow PAS 128 correctly, before any works commenced. They did not look at their surroundings and investigate any furniture which could have utility supplies, in this case the generator and cabins.

Had this been undertaken the direction of the over ground cable could have been identified, prompting further careful investigation prior to the works being undertaken.

Too much reliance was placed on service plans and client certification of services. These documents must be treated as guidance only. All services **must be** identified and traced on all packages.

Appropriate site planning would have identified the generator and cables as a hazard for the works. Works should **not** have commenced in the area of the generator until cable direction and status (live / terminated) was clarified.

There was a failure to adapt and change methodology for site restrictions caused by the dense vegetation. Where site restrictions affect prescribed and agreed methodology of works, works must stop, be reassessed, re-briefed and signed by those completing the tasks.

Perfect Circle Site Management failed to enforce PAS128 / CAT & Genny usage on site by subcontractors. All services need to be traced out, if vegetation prevents the use of CAT & Genny, stop works and reassess the methodology of works. Reduce vegetation following a safe system of work to aid access and identify services.
