# Safety Alert

## Inspection of Recessed (Offset) Gullies

30 August 2019

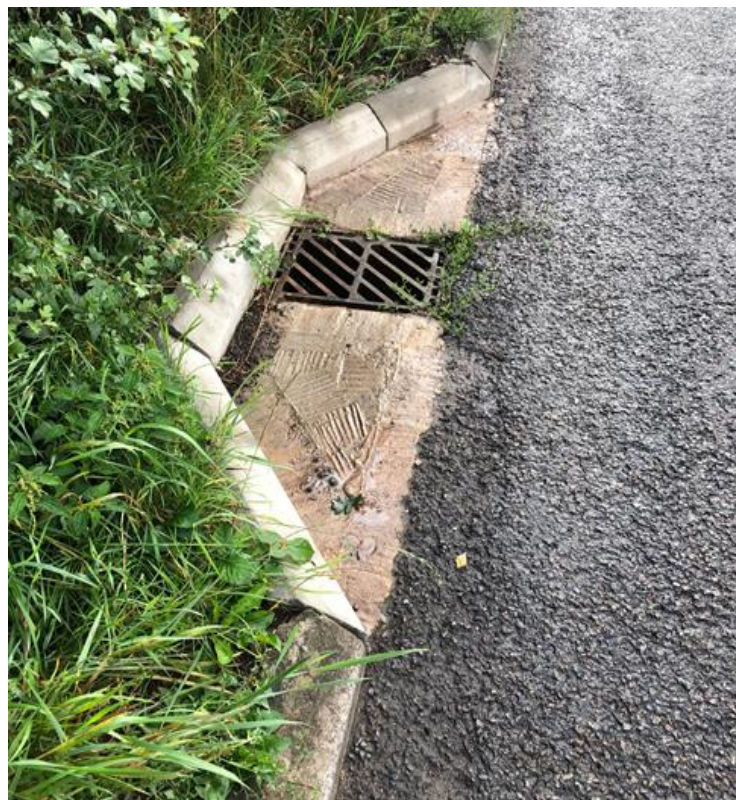
A fatal incident occurred on the A5 in August 2018. Standing water on the carriageway caused by a blocked recessed (offset) gully was a contributory factor to the incident. The Coroner's report into the incident asked for our inspection requirements and processes to be reviewed.

Although no changes to the inspection requirements are proposed **highway inspectors and those staff responsible for the management of highway inspections** shall ensure that:

- All relevant staff have access to and knowledge of the location of recessed gullies;

- Appropriate methodology for recording defects and condition of recessed gullies is being used, for example undertaking a walked inspection if the condition of the gully grating is not clear from a safety patrol carried out at the prevailing traffic speed or video survey;
- Defects are communicated to Local Authorities as the body responsible for the sweeping and cleaning of All Purpose Trunk Roads.
