Safety Alert

Mechanically operated post driver overturning

11 September 2019

The A14 Integrated Delivery Team

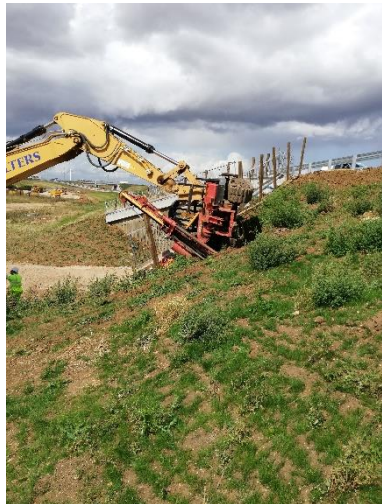
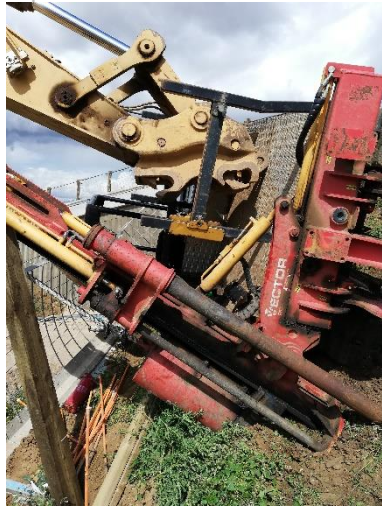
Details of Incident:	Photos:
<p>On the 19th August at 11:15 Am on BN32, section 2 a mechanical operated post driver overturned onto its side .After the plant overturned Walters who were working in the vicinity, assisted with the use of their 36Tonne excavator in gently leaning its arms against the post knocker to avoid any further movement from it. . No persons were injured during the incident. The plant was being operated via an operator using its side controls. The incident occurred after the first fence post was hammered into position at the bottom of the fence run along BN32. It was at the point of raising the hammer from the installed fence post to begin moving the plant to the next post that the post driver started to overturn to the side. The post driver was working on a batter that was at a 1 in 3 gradient but had loose topsoil on the top of it. The gradient was not at a continuous 1 in 3 as the ground is very uneven on that specific batter. The unstable ground underneath the tracks of the machine, combined with the centre of gravity of the machine being at its most unstable point as the hammer is lifted caused it to topple. The operator moved out of the way during the moving of the machine and watched it fall to the side. The incident was reported immediately to members of the A14 section 2 team. The machine was made secure to avoid it falling further with the assistance of a Walters's excavator supporting the main body of the 3 Tonne post driver. K2 recovery came onto site to proceed in safely removing the plant to the bottom of the batter. An investigation commenced, all personal involved in the incident were drugs and alcohol tested afterwards and provided negative result.</p>

<ul style="list-style-type: none"> ➤ An entire review of RAMS associated with their works and selection of appropriate equipment for the task undertaken. ➤ RAMS are also to become more pictorial. ➤ A briefing of the incident relayed to the entire section workforce the following day, along with the presentation being distributed across all other sections on the project. ➤ A point of work risk assessment introduced to workforce and to be used at any area they are working – be it there initial starting point progressing to any additional areas of work that day. ➤ The importance of stop message to be re-communicated to workforce during briefings. ➤ LANTRA training to be completed by the operator of the post knockers. 	<ul style="list-style-type: none"> ➤ Re-iteration of the “stop message” across the workforce to be undertaken as this message was not conveyed on the day of the incident. ➤ Point of work risk assessment to be undertaken and completed after daily briefing. ➤ The assessment of using the most suitable tools for the job and encompassing the surroundings of the work involved in selection of the equipment will be undertaken.
