Safety Alert

Reversing Incident M4 SMP

11 November 2019

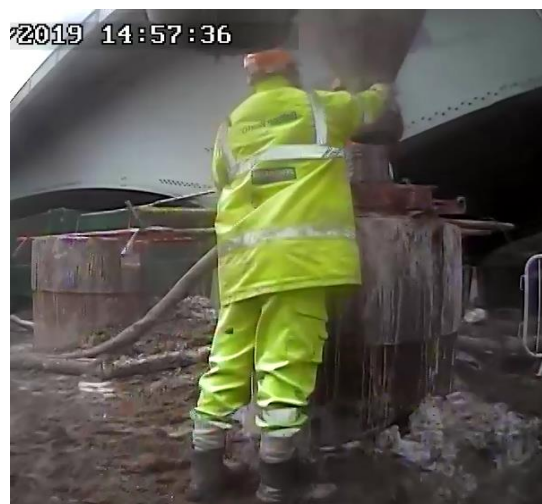
During this manoeuvre a concreting operative was standing beside the pile casing with his back to the vehicle and was struck on the rear of his safety helmet by the vehicles chute.

The operative was shook up but not injured.

➤ People, vehicle and plant interface must be planned and controlled through the use of a suitable hierarchy of control:

- 1) Eliminate** - Where reasonably practicable the need to reverse must be planned out of the work and access gates to work locations installed.
- 2) Minimise** - When reversing cannot be avoided it should only take place in designated reversing areas, with pedestrians physically segregated and the use of reversing aids.
- 3) Mitigate** - Where all the above are not possible, reversing must only take place under the control of a competent, Plant Vehicle Marshall.
