Safety Alert

Lighting Unit dropped through Incorrect fixing

10 December 2019

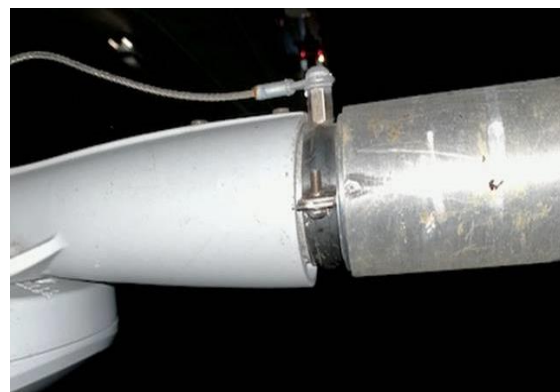
The lighting unit was attached to the horizontal arm of the column, 15m above the carriageway via a horizontal, 100mm long, male to female tapered connection (Photograph 1).

A lanyard was provided to provide secondary protection to prevent the unit falling, however the bracket securing the lanyard would not fit around the main arm of the column bracket and was instead bolted to tapered section of the arm connection.

The unapproved lanyard installation resulted in the lighting unit connection and lanyard bracket working loose and falling to the ground.

Photograph 1. Lanyard incorrectly fitted

Changes to the lanyard connection must be approved by the Designer / Manufacture and agreed with the Overseeing Organisation.

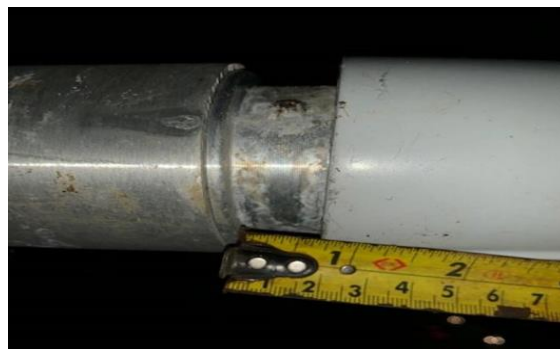
The connection required a full 100mm engagement due to the location of fixing bolts and the internal taper of the lantern fixing.

Photograph 2. Lighting Unit to Column fixing

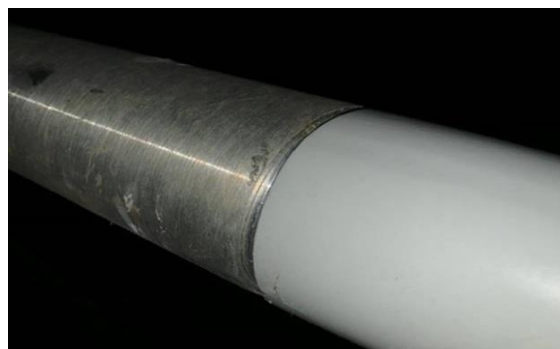
Photograph 3. Correct Fixing Detail

Remedial works were required to all lighting units installed in this manner with the unauthorised detail, to provide the full 100mm connection (Photograph 3) along with re-torquing the fixing bolts to manufacturer's settings.
