Safety Alert

Lighting Column Failure

10th February 2020

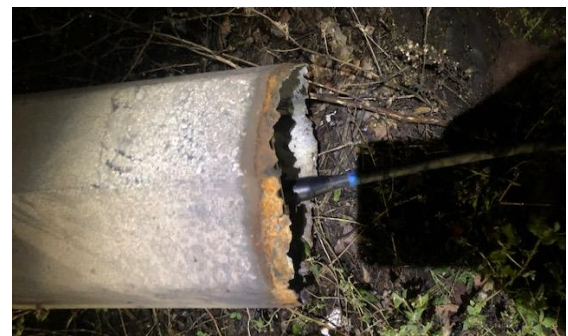
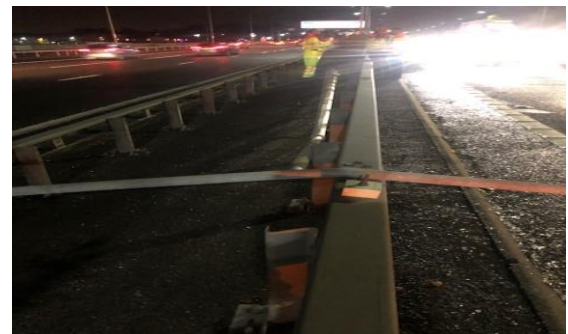
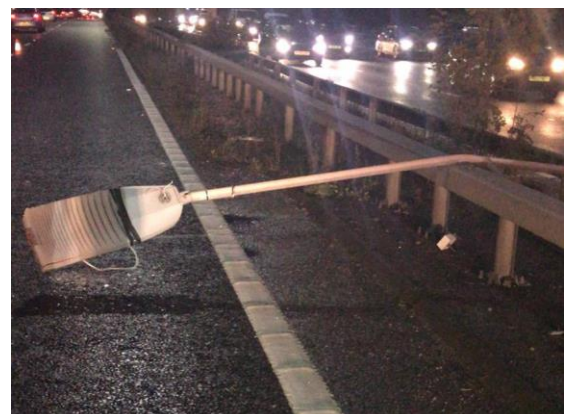
- In the last three months two steel lighting columns have collapsed within motorway central reservations. Fortunately, on both occasions, no harm was caused.
- The cause of failure was due to extensive corrosion below ground level. This corrosion would not have been visible from visual inspections alone.
- Our current guidance [www](http://www.gov.uk/government/uploads/system/uploads/attachment_data/file/431111/Highways_England_-_Guidance_for_the_inspection_of_street_lighting_columns.pdf) requires that all steel lighting columns over 15 years old are structurally inspected every 6 years. (5 years for AMOR contracts).
- Structural inspection includes consideration and implementation of testing requirements.

- Operations teams should follow existing guidance and ensure that the testing and inspection of lighting columns is up to date, prioritising steel columns that are more than 15 years old.
