Safety Alert

STOP Think! Moment – Skid Steer Roll Over

30th January 2020

Osborne

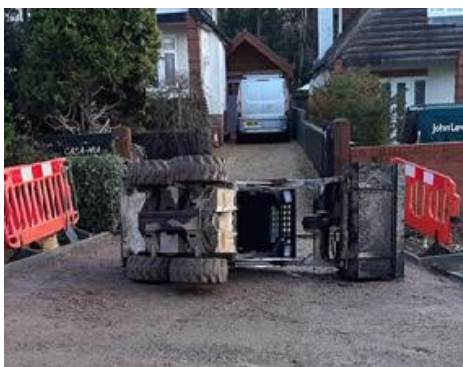
Skid steer on its side

After placing a bucket of tarmac the operator reversed down a gentle incline to get more. As he reversed and turned, his rear wheel clipped a curb edging which was not seen by him.

This caused him to think the loader was going to turn over and he panicked. He straightened his legs to brace himself which in turn caused the bucket to rise rapidly (a foot pedal operates this movement) causing further instability. Coupled with the rearward momentum and the heavier end of the loader to the rear, it rolled over onto its side.

The driver was uninjured and the loader undamaged.

1. Operators to be briefed on the incident and be reminded that whilst the slope in this incident was not significant, loaders must be used in accordance with instruction, training and the manufacturers operation manual.
2. Check that all operators hold an approved competency card, correctly endorsed for the plant to be used. In this case:
 - a. CPCS with the category of A23 skid steer loader, or;
 - b. NPORS with category N212 skid steer loader
3. That consideration is given to the use of other alternative equipment for material handling which has better stability e.g. excavator or dumper.
4. Where practicable ALL plant should avoid reversing unless it is needed for safety purposes, for example reversing down a slope with a load as shown opposite.

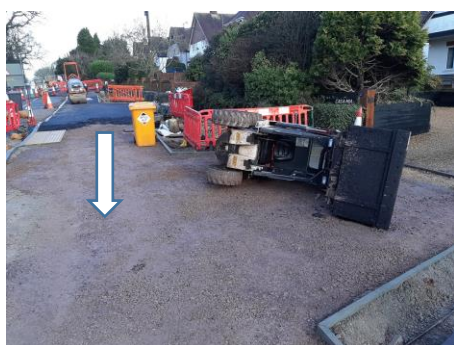
Arrow indicates direction of travel
