Safety Alert

Lower Thames Crossing Pre-Enabling Works

Towable Equipment

March 2020

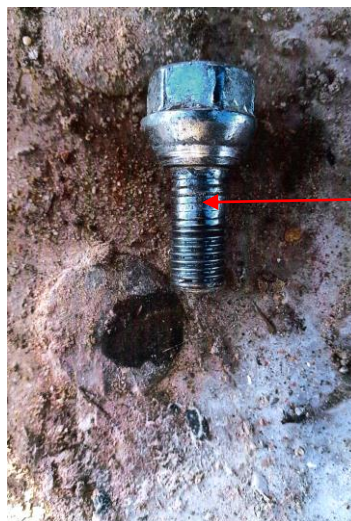
- The wheel studs were loose, which was not identified by the driver during his visual inspection

Wheel stud with 50% of thread damaged

- A fitter visited site a week before and identified that the wheel nuts were loose and did not tighten them.
- The quality of the walk round visual inspection was inadequate
- The driver did not have the tools to physically check the wheel stud torque settings

- Periodically assess individuals carrying out vehicle/trailer checks.
- Ensure that the correct tools are available to carry out physical checks of wheel stud torque settings
- Ensure thorough delivery inspections take place on receipt of equipment/plant

- Coloured wheel stud indicator alignment should not be used as sole confirmation that the wheel studs are all securely held in place.
- Checking wheels studs for the correct torque settings is critical to the safety of the equipment when towed.
- As a result, a more detailed trailer pre-start checklist has been introduced across Balfour Beatty.

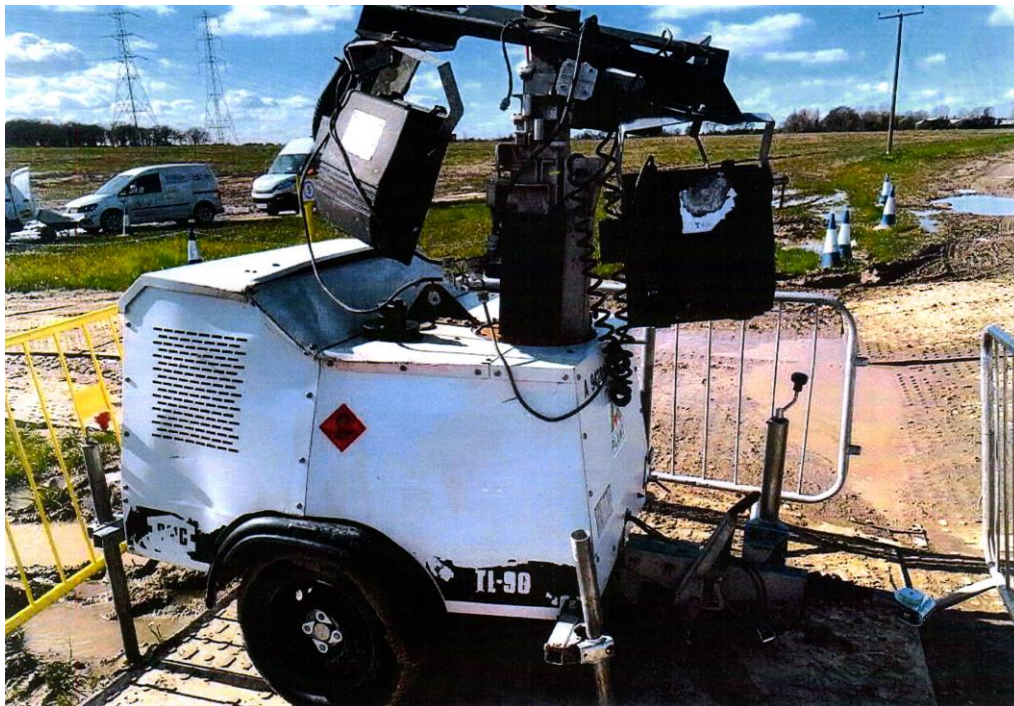
On Friday 6th March 2020 an 'A' Plant trailer mounted lighting tower was being towed, using a Toyota Hilux 4x4, on the Lower Thames Crossing project when the near side wheel became detached causing the trailer to tip on its offside.

Lighting tower after the incident
