# Safety Alert

## Fire Hazard from Hot Exhaust

4 May 2020

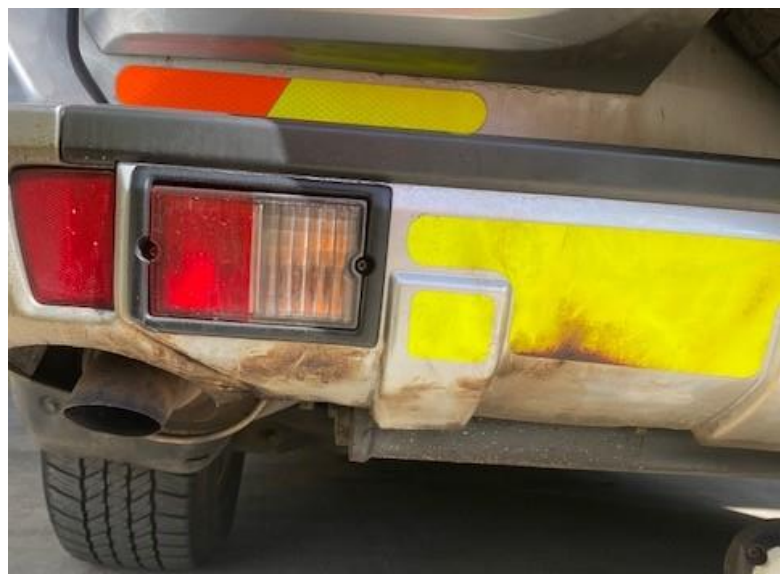
- Whilst a Traffic officer vehicle (TOV) was parked at a park up point (PUP) on the M61, The Traffic Officer (TO) noticed that the TOV started to raise its Revs, this is a natural action that the car does known as “re-gen”. Just after this stopped the TO then smelt something burning and looking in the wing mirrors noticed smoke coming from the rear of the car. The TO immediately moved the car forward and got out and saw smouldering of the grass to the rear of where the TOV was parked.

- The TO extinguished the smouldering grass and on looking at the rear of the TOV noticed there were a number of scorch marks on the paintwork.
- Following the incident, the TOV was inspected at RIVUS fleet Warrington to ensure there were no inherent faults and there was no structural or mechanical damage to the TOV.

- On speaking to the mechanic undertaking the inspection we were informed the re-gen process can produce heat of up to 600 degrees +.
- The DPF Regeneration process is the process of **removing soot built up over time from the diesel particulate filter**. It is done in one of three modes; passive, parked, or active during which very high temperatures are reached.

- Follow the Advice in your Mitsubishi vehicle Handbook which states: Never park your vehicle in areas where there are natural combustible materials such as dry grass or vegetation that may come into contact with a hot exhaust system since a fire could occur.
- Timely Reporting of any Park up Points requiring maintenance.
